Environmental Flow Recommendations for Reserve Flows in the Mara River, Kenya and Tanzania

GLOWS – FIU. 2012. Environmental Flow Recommendations for the Mara River, Kenya and Tanzania. Global Water for Sustainability program (GLOWS). Miami, FL

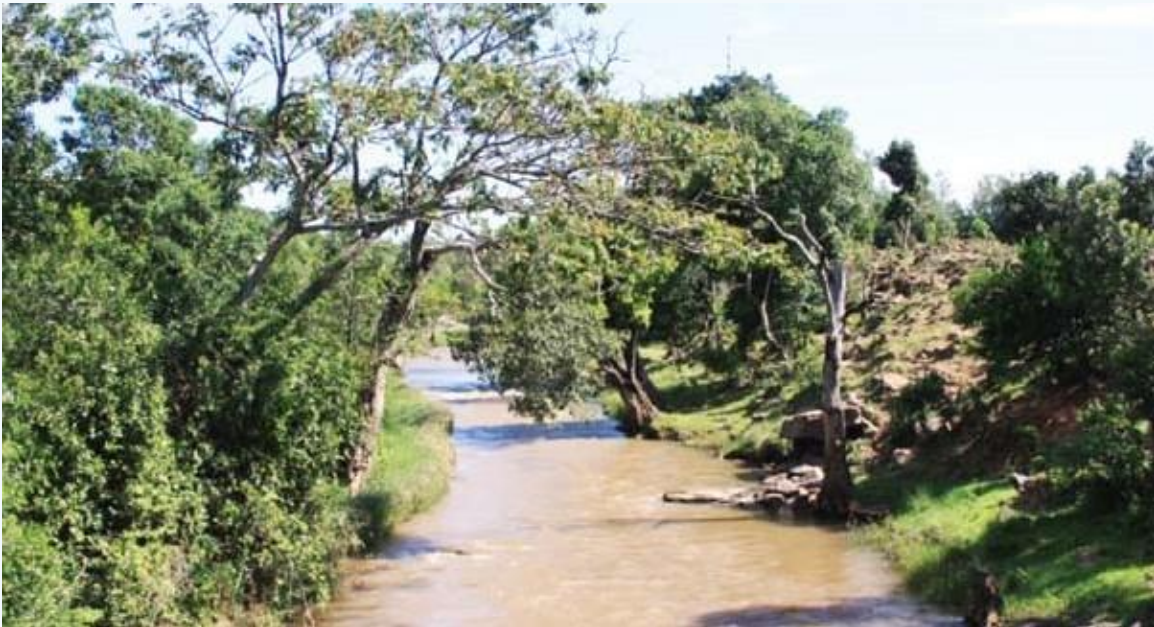
Site 1 – Amala River near Kapkimolwa

- **Location:** Amala River, a main tributary to the Mara, at the bridge near Kapkimolwa village, on the border between Bomet and Narok Districts, near gauging station 1LB02
- **Altitude:** 1860 masl
- **Surrounding Land Use:** Small-scale settlement, subsistence farming and cattle rearing

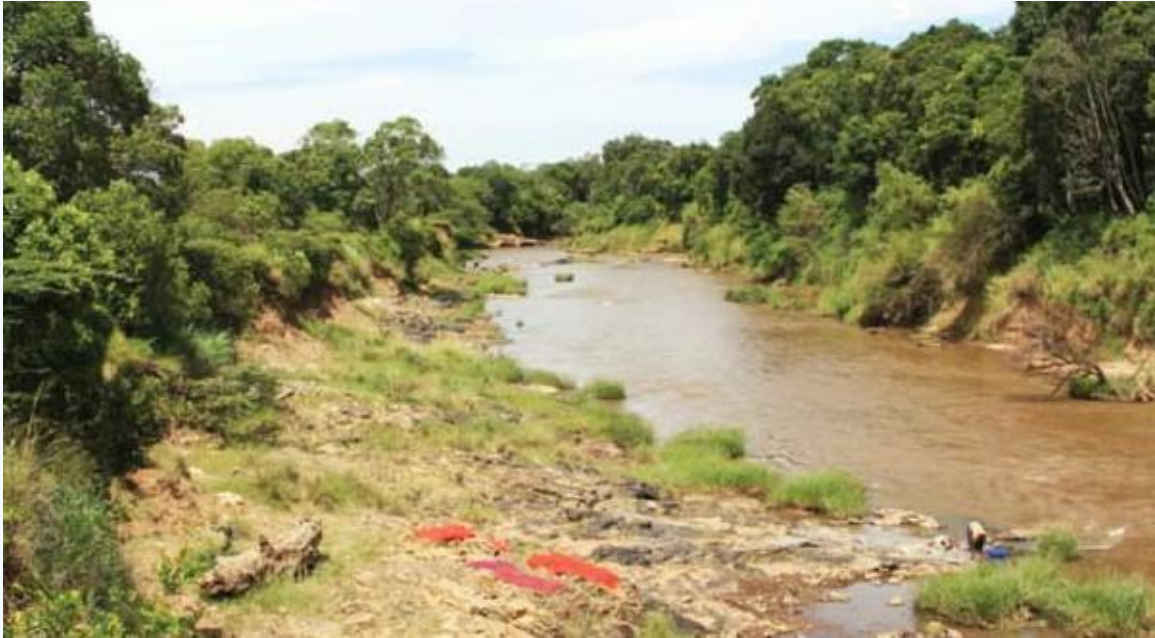
Site 2 – Mara River near Mara Safari Club

- **Location:** Downstream of the confluence of the Amala and Nyangores Rivers, in the region called Ngerende, north of the boundary of the Maasai Mara National Reserve
- **Elevation:** 1687 masl
- **Land Use:** Wildlife conservation areas, livestock grazing and some large-scale irrigation farming

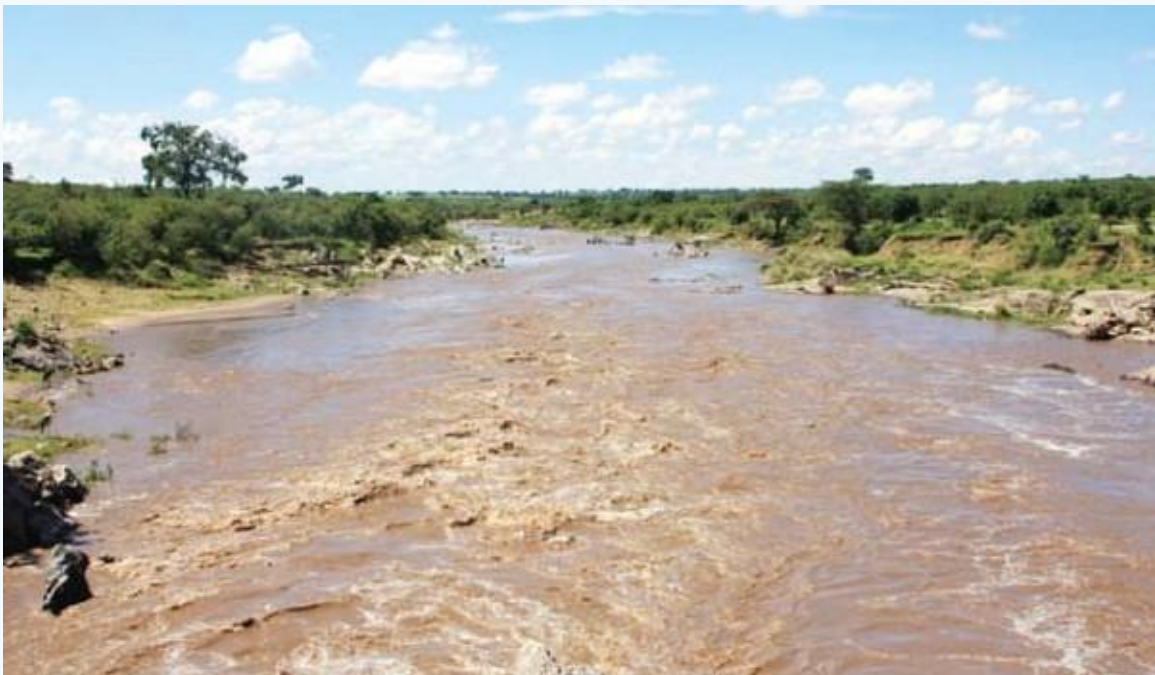
Site 3 – Mara River at Kenya-Tanzania Border

- **Location:** Border between Kenya and Tanzania, and the Maasai Mara National Reserve and Serengeti National Park, just downstream of the Purungat Bridge
- **Elevation:** 1470 masl
- **Land Use:** Wildlife grazing and tourism

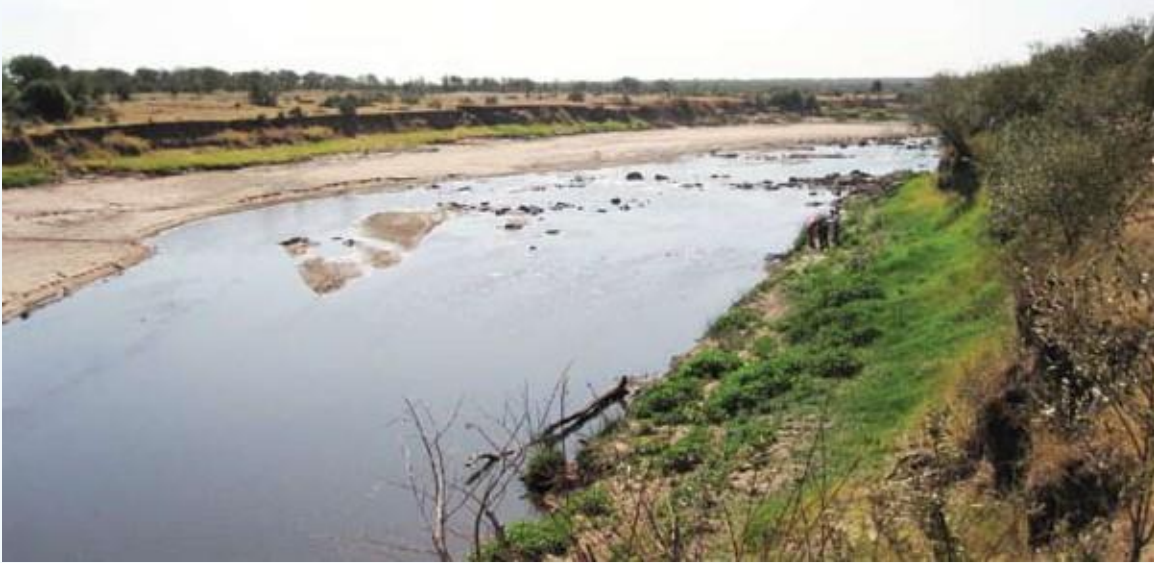
Site 4 – Mara River at Kogatende

- **Location:** Inside the Serengeti National Park 2 km downstream from the Kogatende Rangers' Station
- **Elevation:** 1403 masl
- **Land Use:** Wildlife grazing and tourism

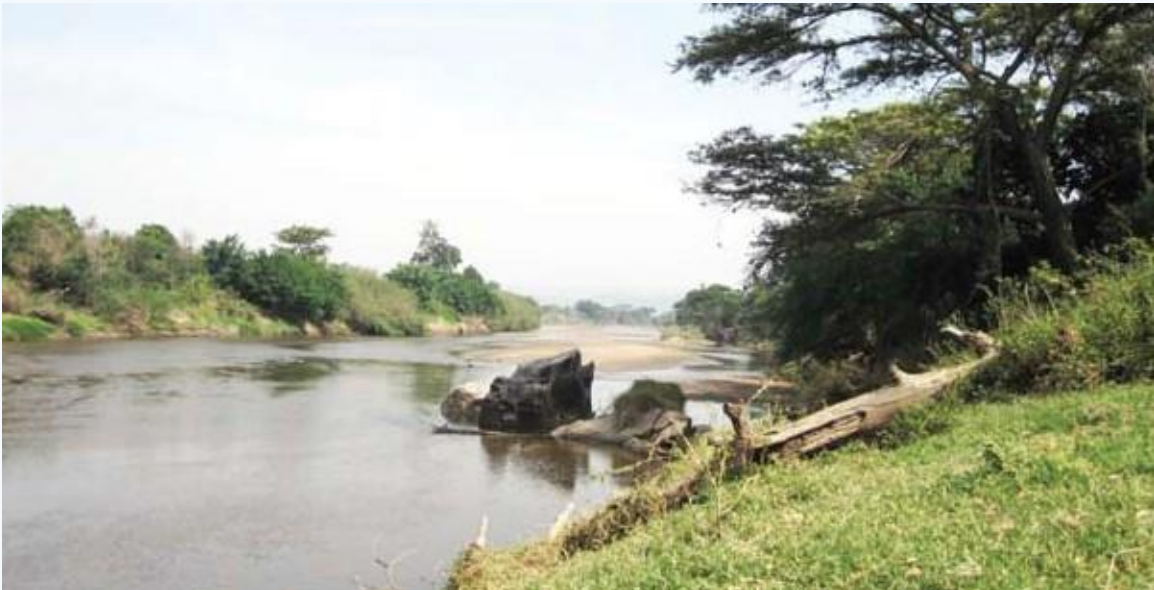
Site 5 – Mara River at Mara Mine

- **Location:** In Tanzania at the gauging station 5H2, Mara Mines, south of Murito Village and north of the Mara Wetland
- **Elevation:** 1183 masl
- **Land Use:** Moderate levels of farming and livestock grazing with large-scale and artisanal gold mining nearby

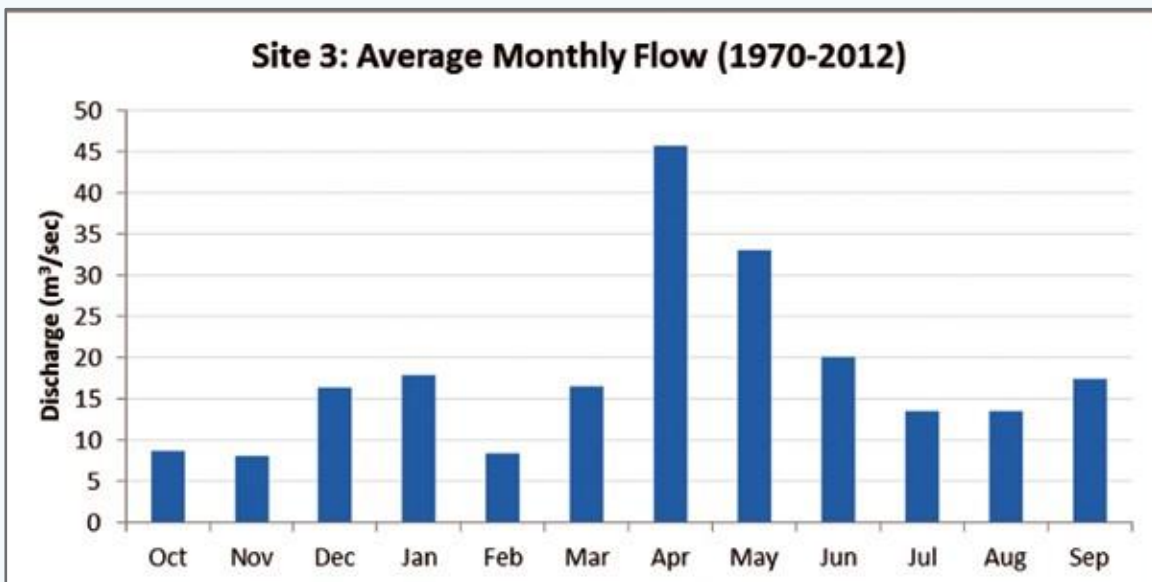
Figure 6: Monthly flow at EFA Site 3, averaged over all the years of record (1970-2012)

At Site 3, in the middle Mara straddling the Kenya-Tanzania border, average monthly flows during normal years can range from 2.7 to 77.7 m³/sec, with an average of 18.3 m³/sec (Figure 6). However, during drought years they can be as low as 1.1, and during wet years, they can be as high as 296.7 m³/sec.

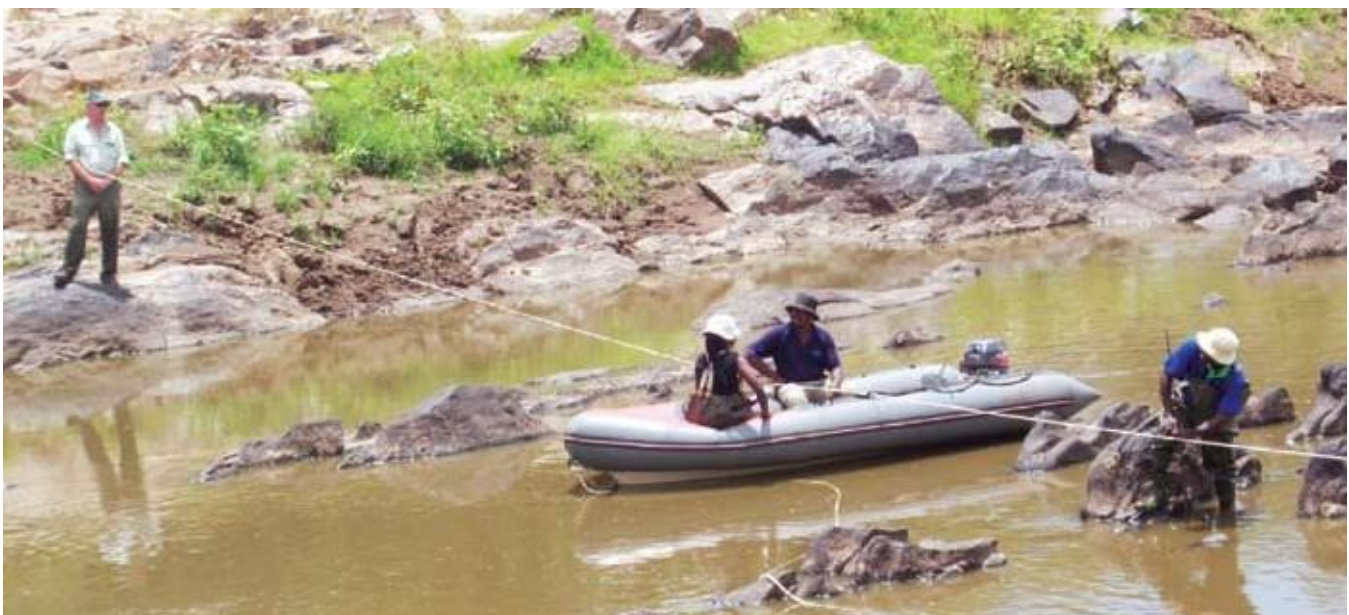
Image 3: Project technical staff surveying river cross sections

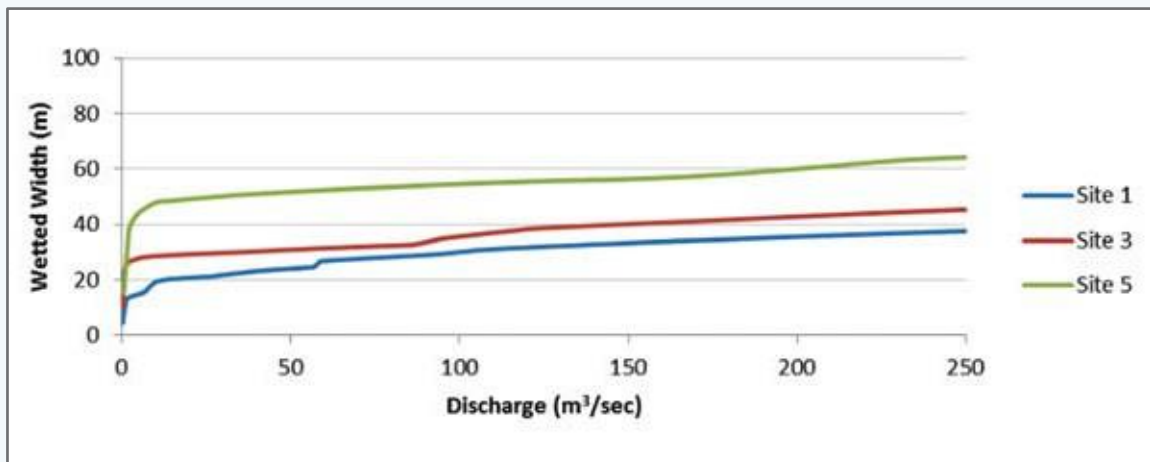
Figure 13: Simulated relationships between wetted width, a key ecological parameters and discharge at EFA Sites 1, 3 and 5

From these model projections, various flow parameters can be graphed as a function of discharge in order to determine critical flow levels (Figure 13). For example, the wetted width of a river is a baseline indicator of how much aquatic habitat is available at any particular discharge. Relationships between wetted width and discharge at all five sites generally had a characteristic shape: steeper at low discharges with one or multiple break points. These break points may correspond to water rising over channel features such as bars and boulders, or an irregular channel bed or banks. Once water fills the channel and begins to rise up the stream banks, the rate of increase of wetted perimeter for each unit increase of discharge decreases. This process creates a break in slope, an inflection point, in the plot of wetted perimeter to discharge. This break point is important in defining minimum streamflow requirements (Gippel and Stewardson, 1998). At Site 1, these break points occurred at 0.5, 8 and 58 m³/sec. At Site 3, they occurred at 0.7 and 90 m³/sec. At Site 5, they occurred at 1.5 and 180 m³/sec.

This and other series of relationships between discharge and flow parameters, including water depth, flow velocity, and wetted perimeter, were used by the EFA team to translate necessary flow parameters for different components of the river ecosystem into minimum required discharge values. For example, the riparian vegetation specialist may recommend a given river width in order to inundate emergent vegetation critical for sustaining in stream habitat. The hydraulic model can then be used to translate this width into a discharge value that can be used by water resource managers.

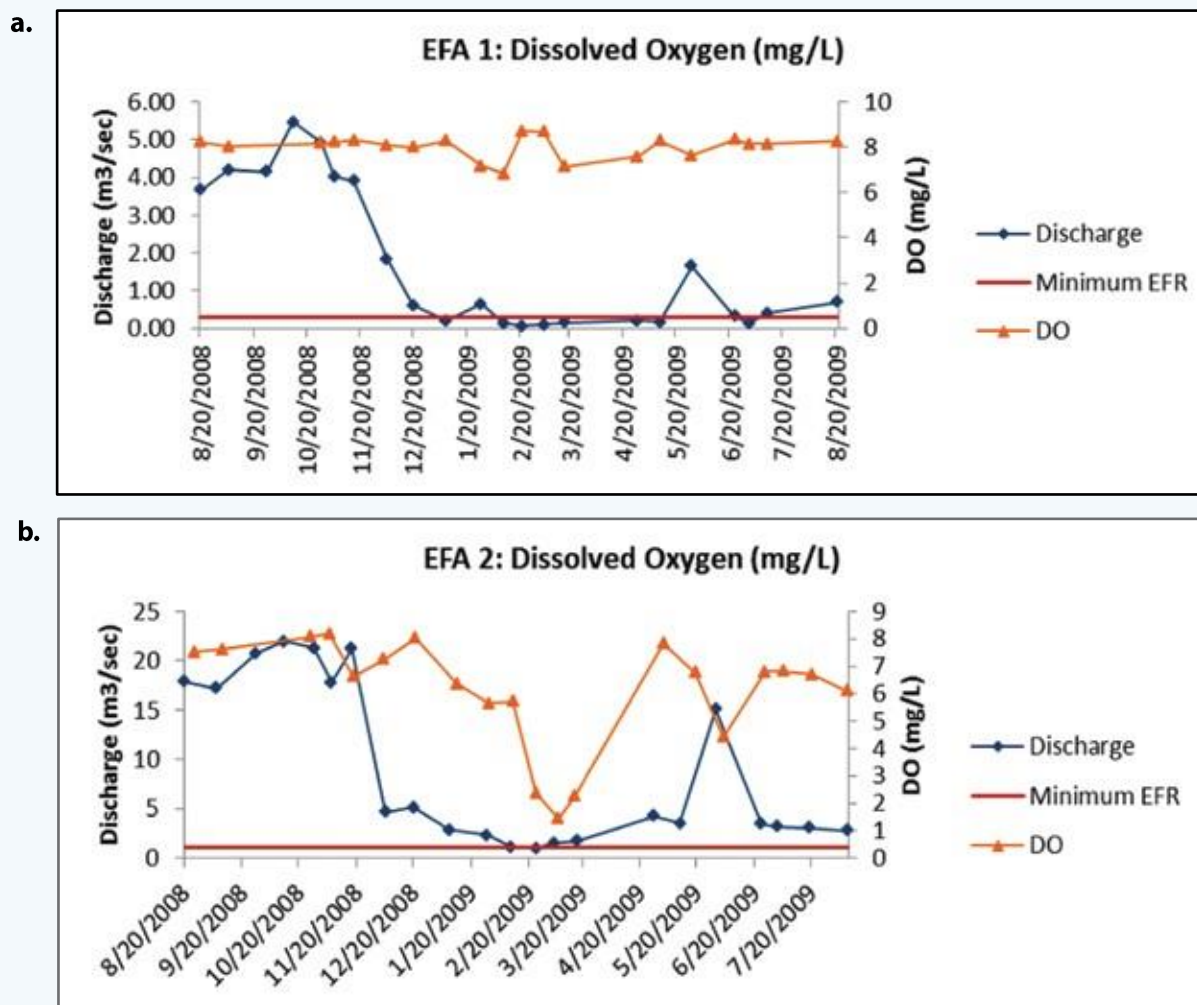
Figure 15: Dissolved oxygen and discharge measured twice monthly from August 2008- August 2009 at a) EFA 1, b) EFA 2 and c) EFA 3, as compared to the environmental flow recommendations (EFR) for drought year dry season flows at that site

Data collected in the upper and middle portions of the basin from 2008-09 found that water quality was strongly affected by low flow levels, particularly at sites further downstream (EFA Sites 2 and 3). Results are shown below for dissolved oxygen (DO), which tends to decline under poorer water quality (Figure 15). Low DO levels can have direct, negative effects on the biological health of a river. At both Sites 2 and 3, when discharge levels dropped below the drought year, low flow environmental flow recommendation (Minimum EFR), DO levels dropped to below 2 and 3 mg/L, respectively. DO levels below 3 mg/L are generally considered to be harmful to aquatic life and are below Tanzania's standards for the poorest category of receiving waters. These findings lend support to the importance of maintaining discharge above the minimum EFRs.
