Table of Contents Field Investigations Study

ANNEX C: GEOTECHNICAL INVESTIGATIONS

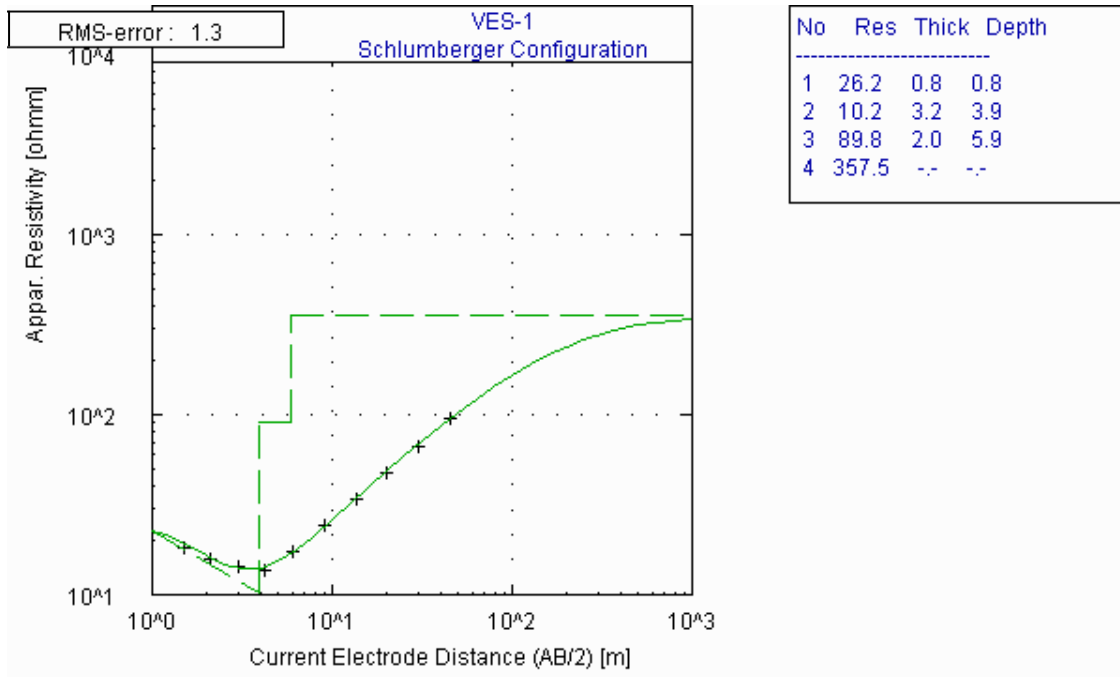
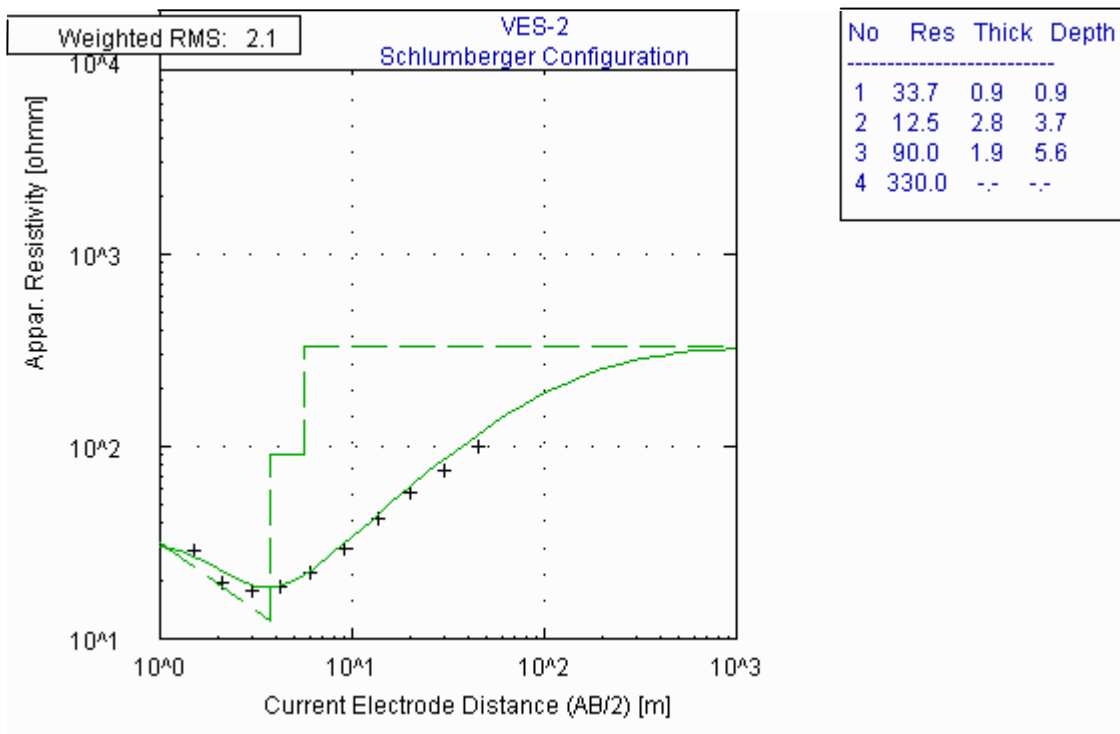
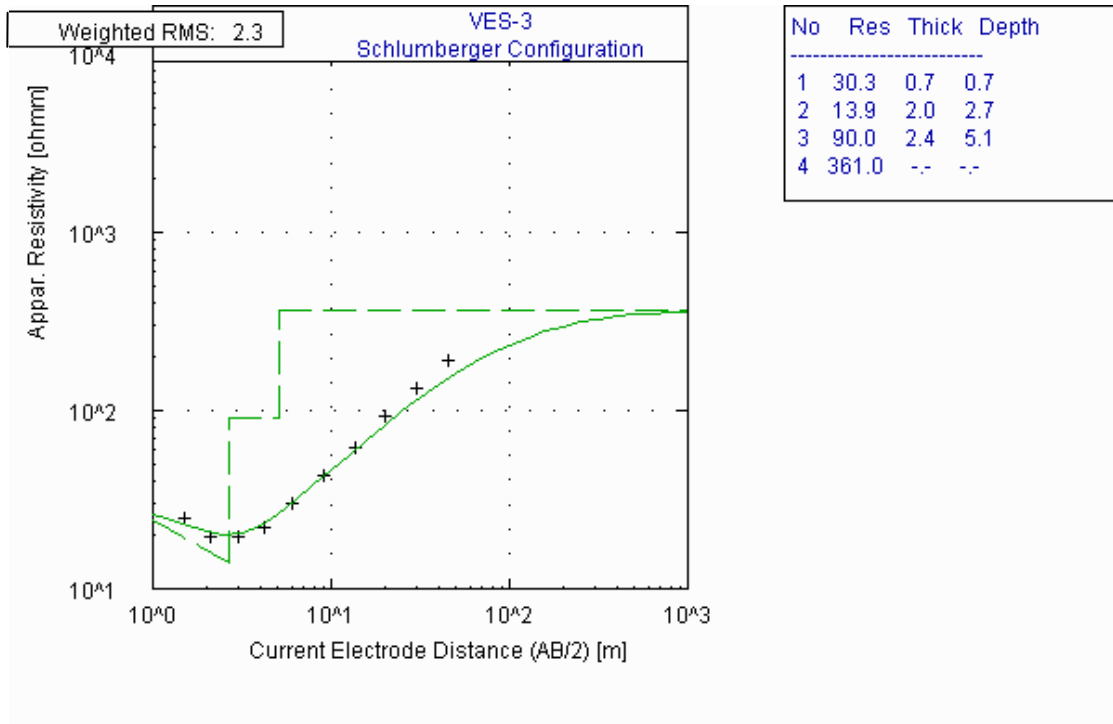
Upstream Weir Site

Annex 2: Smoothed and Interpreted VES Curves

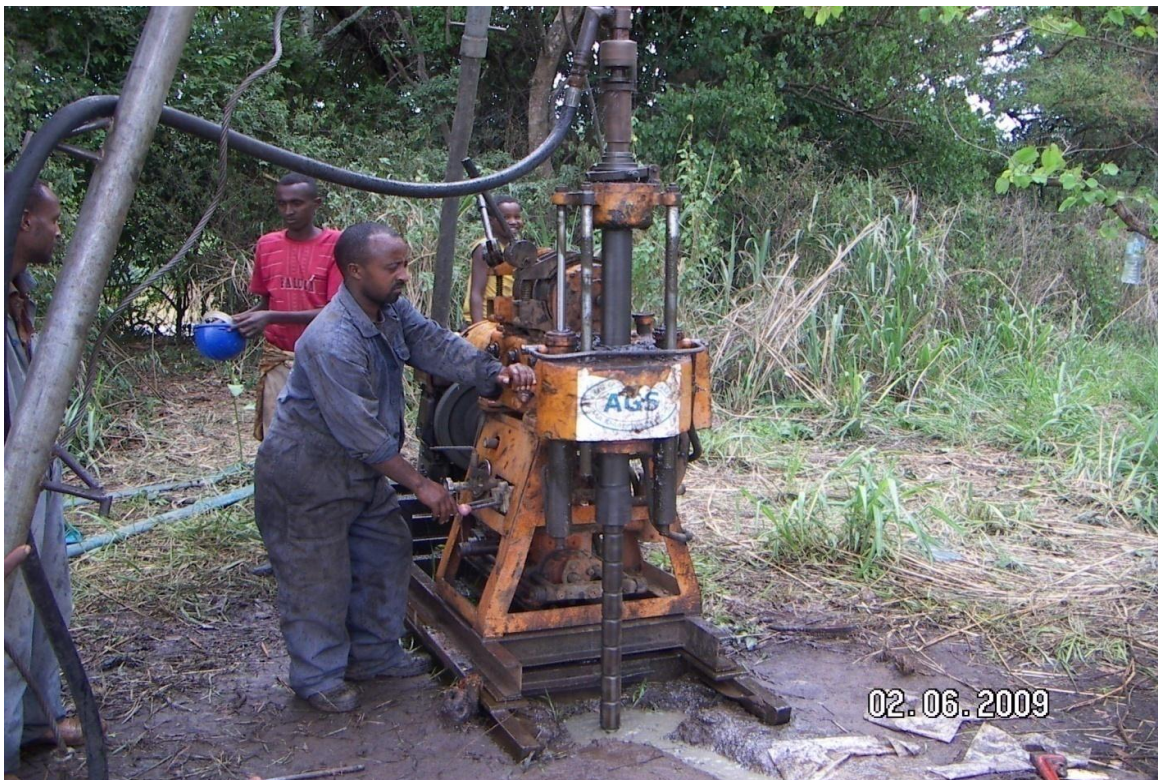
Figure 1. Core drilling operation at DWBH-1 (left bank)

Rotary core drilling was conducted with a portable skid mounted core drilling rig fitted with water pump, appropriate core sampling and in-situ testing (SPT) equipment. Dry drilling technique was used in soils and drilling water was used when drilling in hard rock layers. Temporary casing was installed in overburden drilling to prevent collapse of materials. Generally, the methods applied in the investigation were in compliance with relevant BS and ASTM standards for site investigation (BS 5930:1981, ASTM D2488).

As soon as cores were removed from core barrels, the retrieved core samples were placed in a standard partitioned wooden core boxes starting from top to bottom with a proper labelling indicating the top and bottom of each run and properly logged and eventually photographed. Colour photos showing core samples in core boxes are shown in appendix 5. A picture showing core drilling operation at BH1 is shown in figure 1 below.

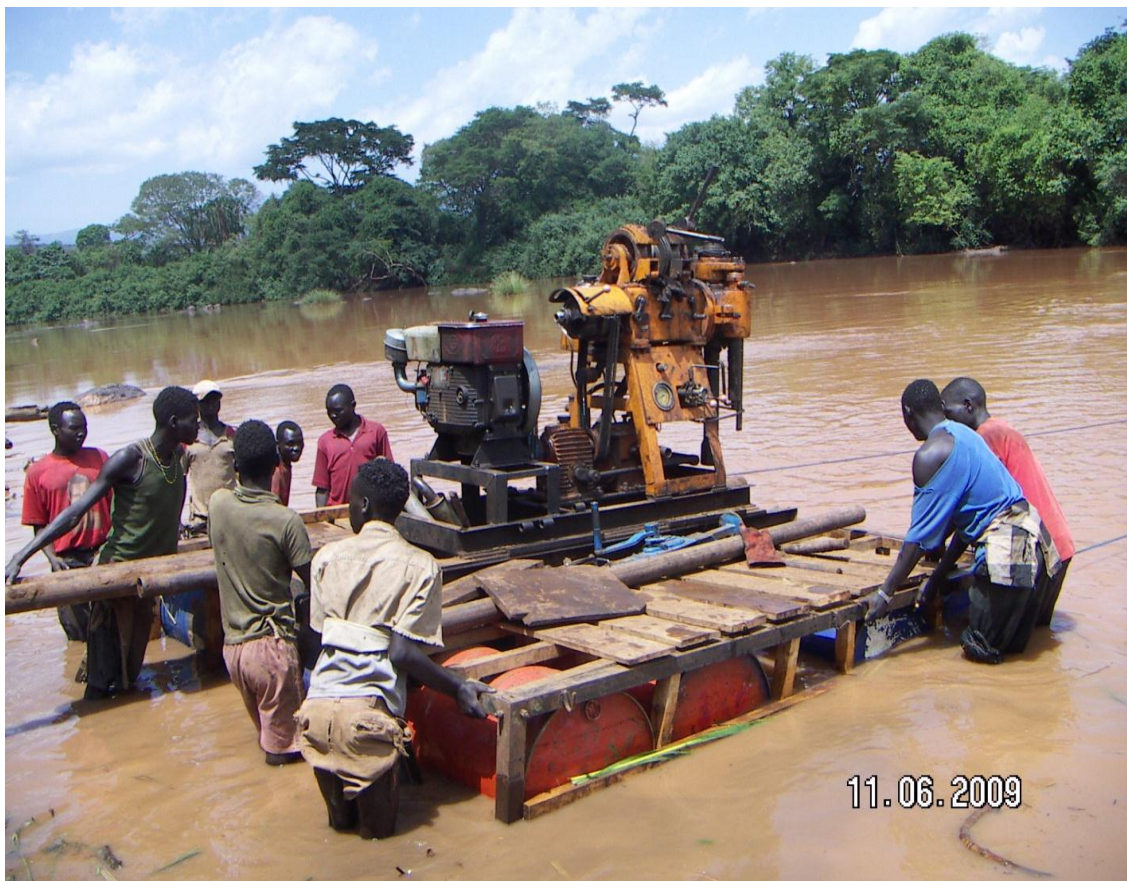
Figure 2. Picture showing a raft carrying drilling rig over Didessa river during inter-borehole movement.

The drilling rig along with drilling tools and crew were moved from one side of the river bank to the other which is about 120m long with the help of a 3mX3mX1m raft which was assembled on site. The buoyancy space was obtained from a series of oil drums that were stuck within the wooden frames. Picture of the raft used for inter-site mobilization is shown in figure 2 below.

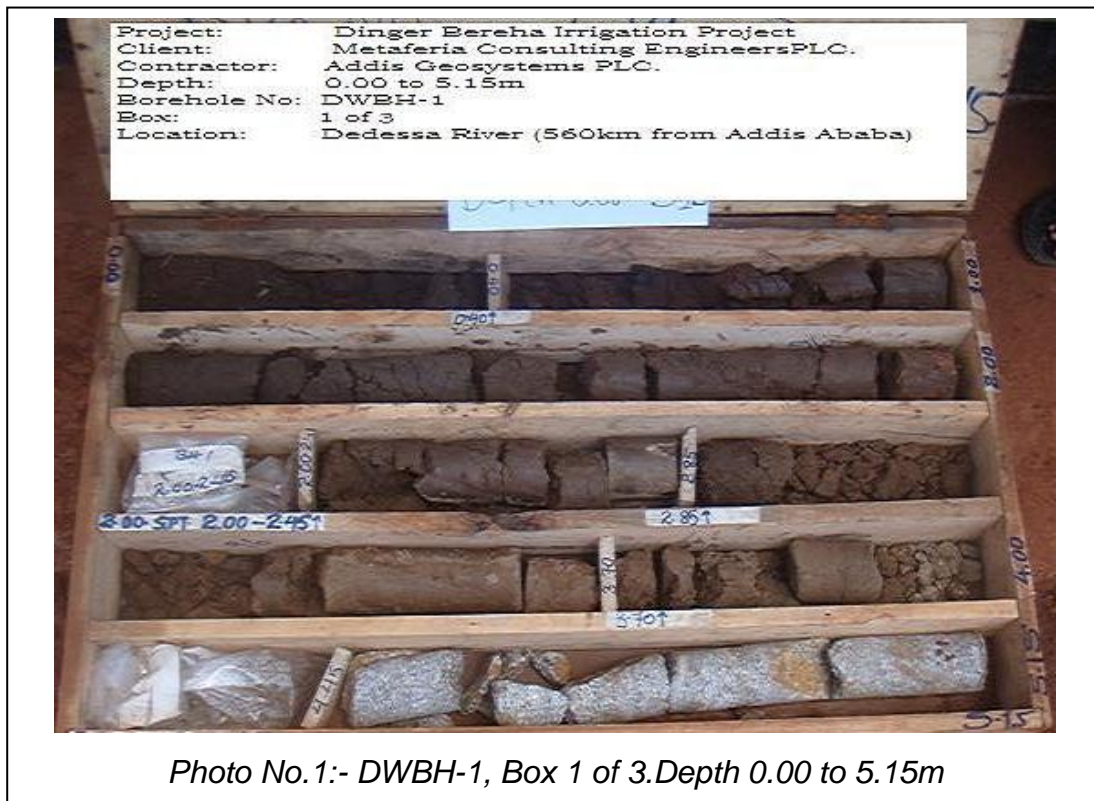
Annex 2: Core Photos

The core drilling showed presence of two different geological layers at the proposed weir site. The two boreholes drilled at both sides of the river to a maximum depth of 12.25m depth disclosed the existence of biotitic quartz feldspatic gneiss overlain by a sandy gravelly clay soil of alluvial origin. The river bed is more or less flat characterized by exposures of crystalline basement rock namely Gneiss. This crystalline basement rock is strong, coarse grained and massive with some fracture at the top part. The geotechnical features of the layers are described as follows:

The overburden layer which is alluvial in origin is loose to very dense, dark grey to reddish brown, sandy gravelly clay with some silt. The standard penetration test (SPT) value conducted in the layer has an N-Value in the range of 23 to 39 for 30cm depth penetration. It has a maximum thickness of 4.75m in bore hole DHBH-1.

This layer is coarse grained, fresh, biotitic quartz feldspatic gneiss encountered beneath the overburden which is of alluvial origin. It shows fracturing and slight weathering appearances along discontinuities. The rock is moderately to highly fracture towards the top and slightly fractured to intact and very strong towards to bottom of the boreholes. This layer was encountered from 4.45m to the end of drilled depth in both bore holes.

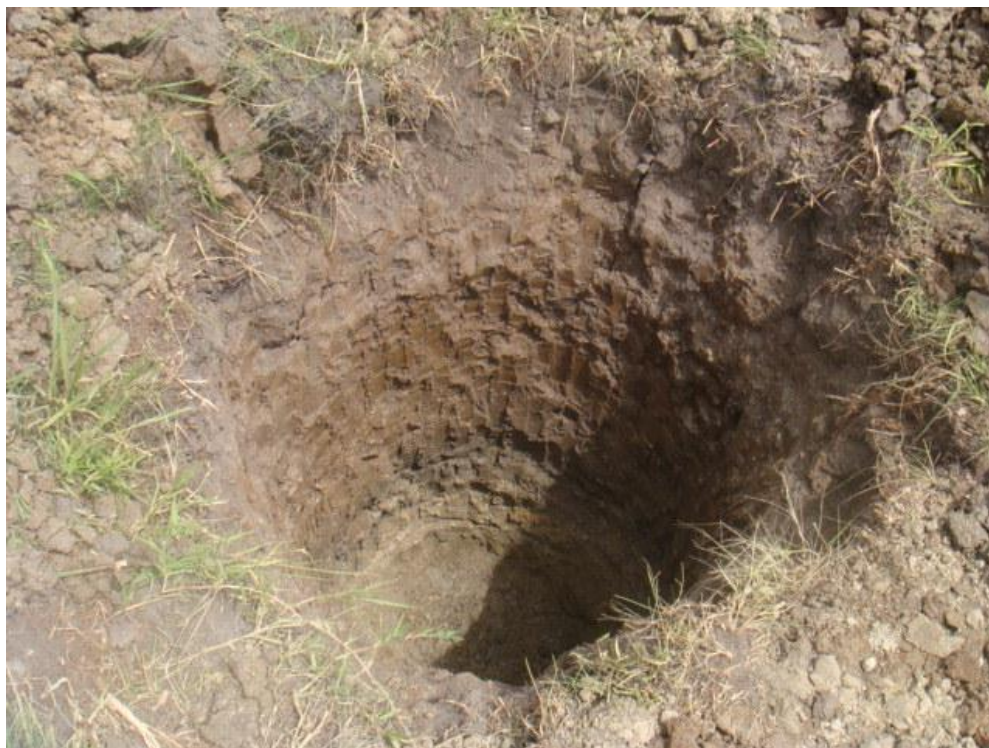
Test pit in feeder canal alignment

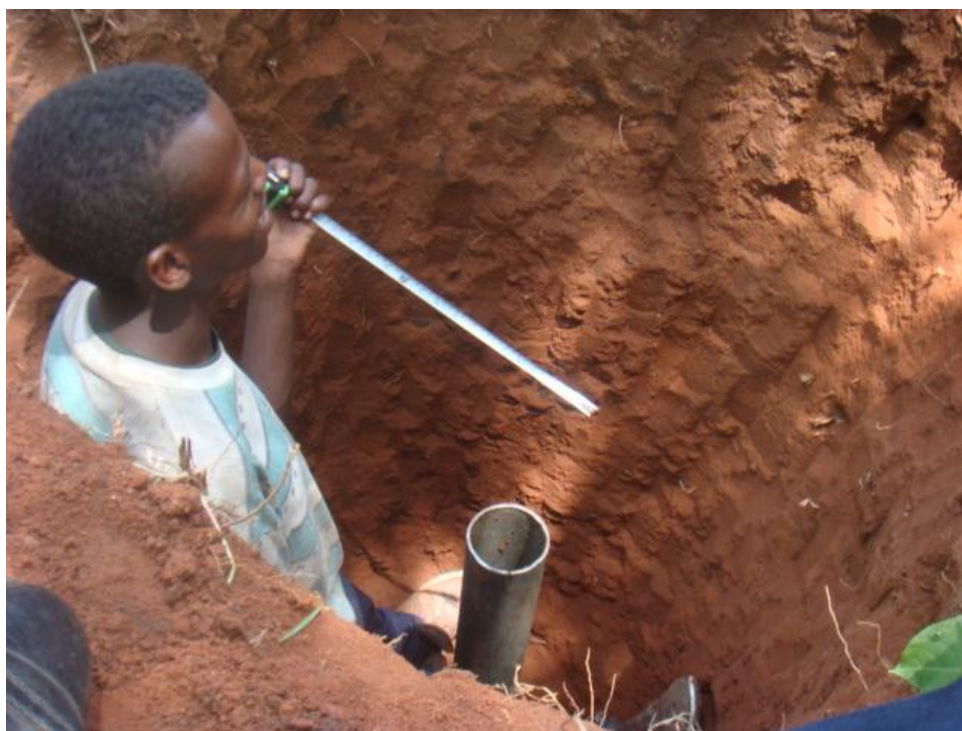
Infiltration test

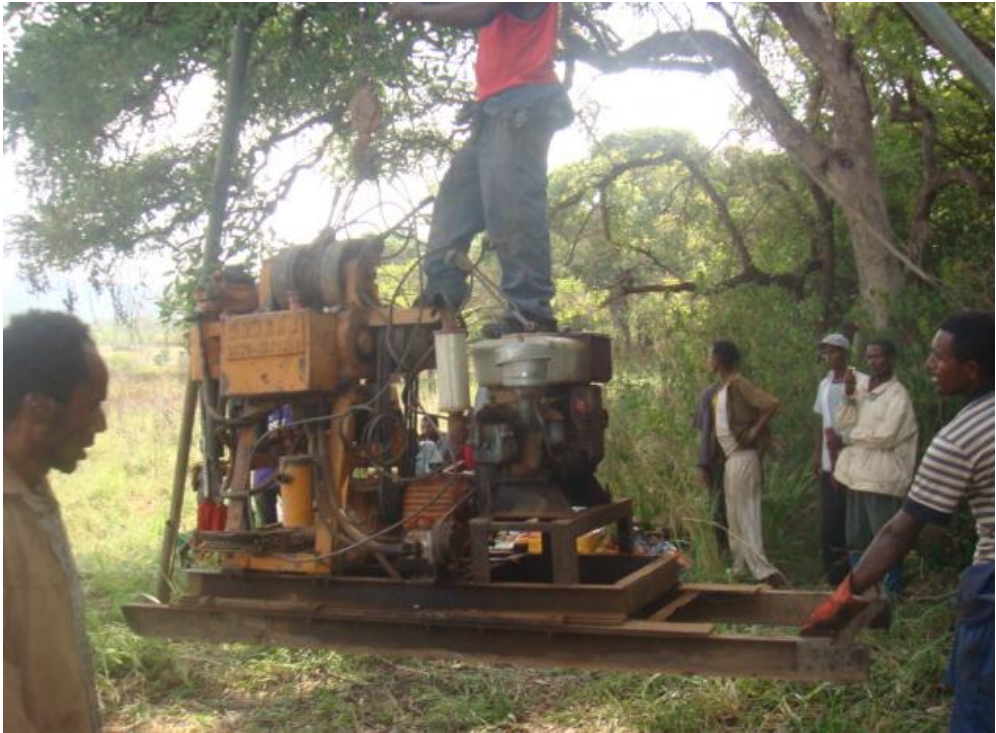
Skid mounted rig
