Table of Contents Field Investigations Study

VOLUME I: MAIN REPORT

VOLUME II: ANNEXES

ANNEX C: GEOTECHNICAL INVESTIGATIONS

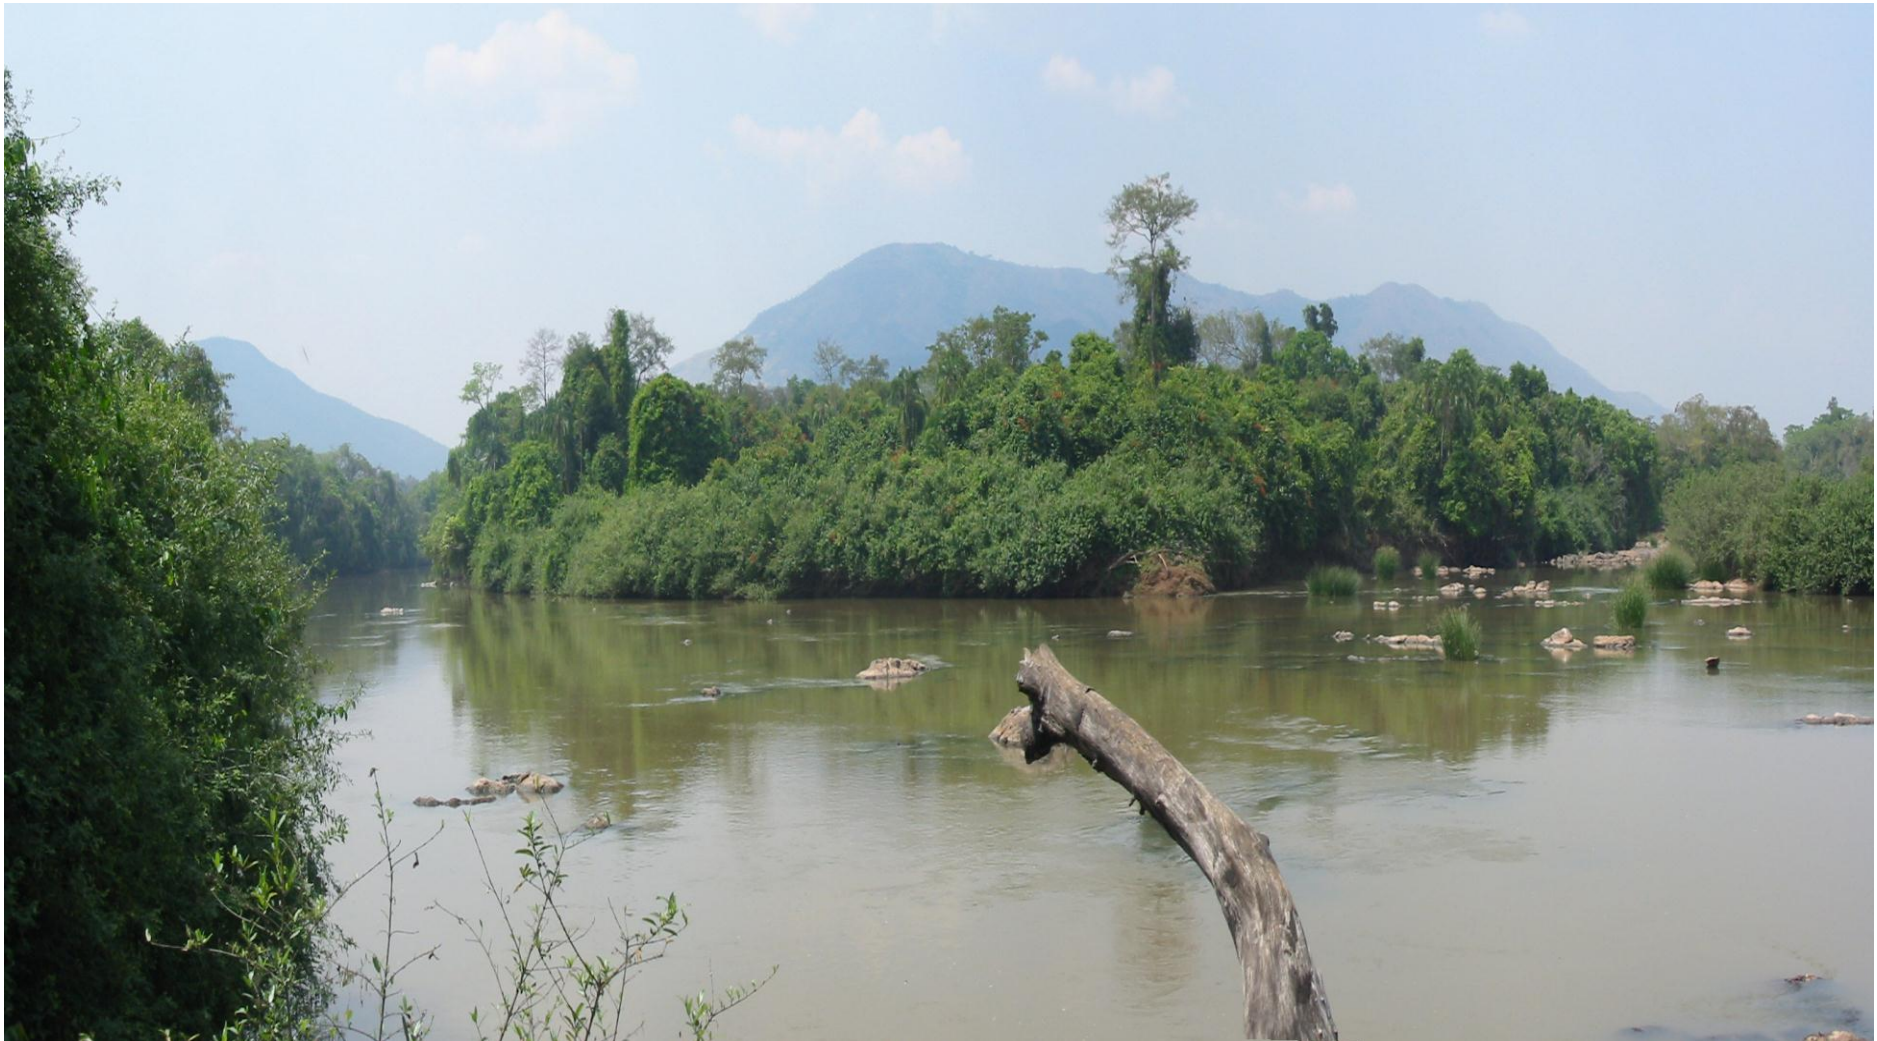
Plate 1.3: View on bifurcation downstream of diversion site

Plate 1.3: View on bifurcation downstream of diversion site

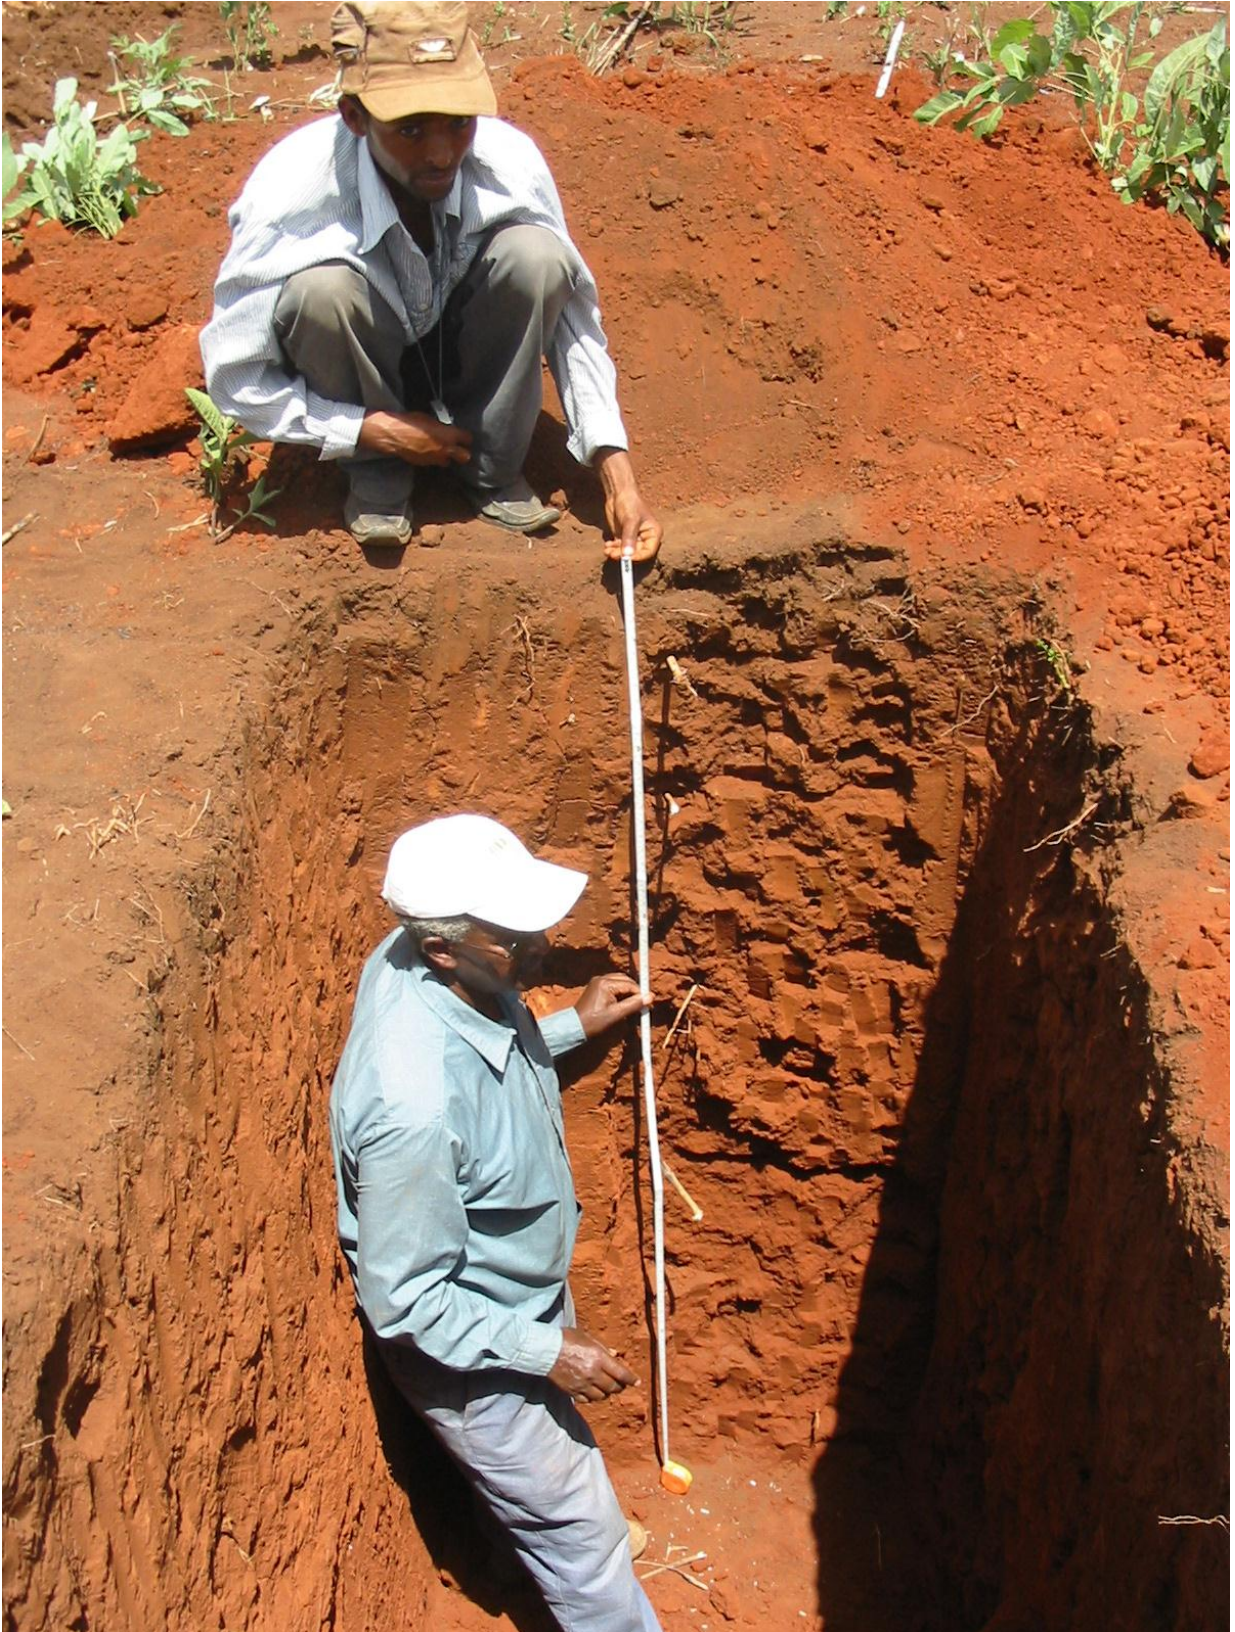
Plate 5.1: Inspection of profile pit depth #1

The main observations recorded for profile pits were layer-wise, color, texture, structure etc. Moreover, other site-specific observations including land use, topography, cropping pattern, parent material, erosion status etc. were also described and recorded according to the FAO guidelines. Soil color description was preformed according to Munsell soil color charts. Profile description and details of soil laboratory results of model profile pits are presented in Appendix 5A. Pictures (1&2) taken during survey time are illustrated below in Plates 5.1 and 5.2.

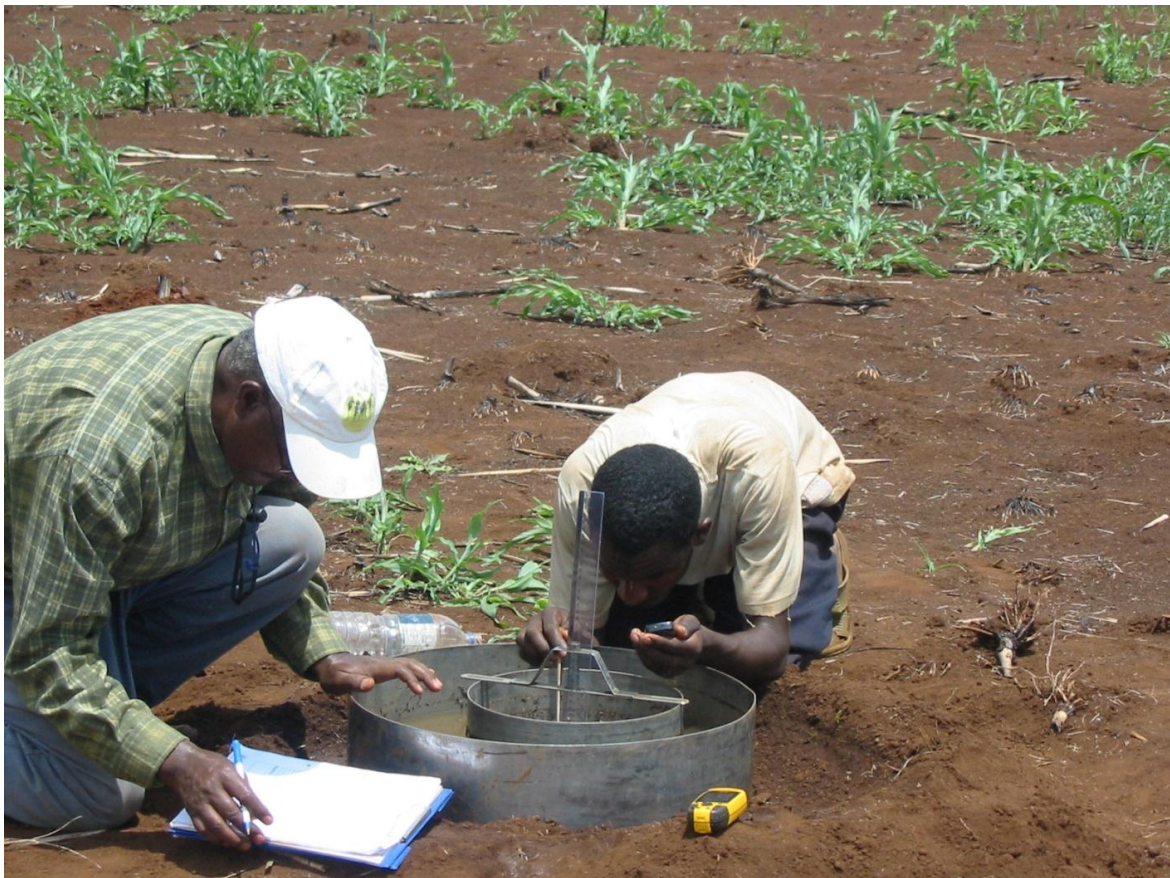
Plate 5.3: Determination of infiltration rates using double ring infiltro-meter

In-situ infiltration and hydraulic conductivity measurements were made on representative 11 model profile pits, which is 10% of the Profile pits. The infiltration measurements were determined at three sites, 10m apart from each other, using Double Ring Infiltrometers. Picture taken during the study time is presented below in Plate 5.3.

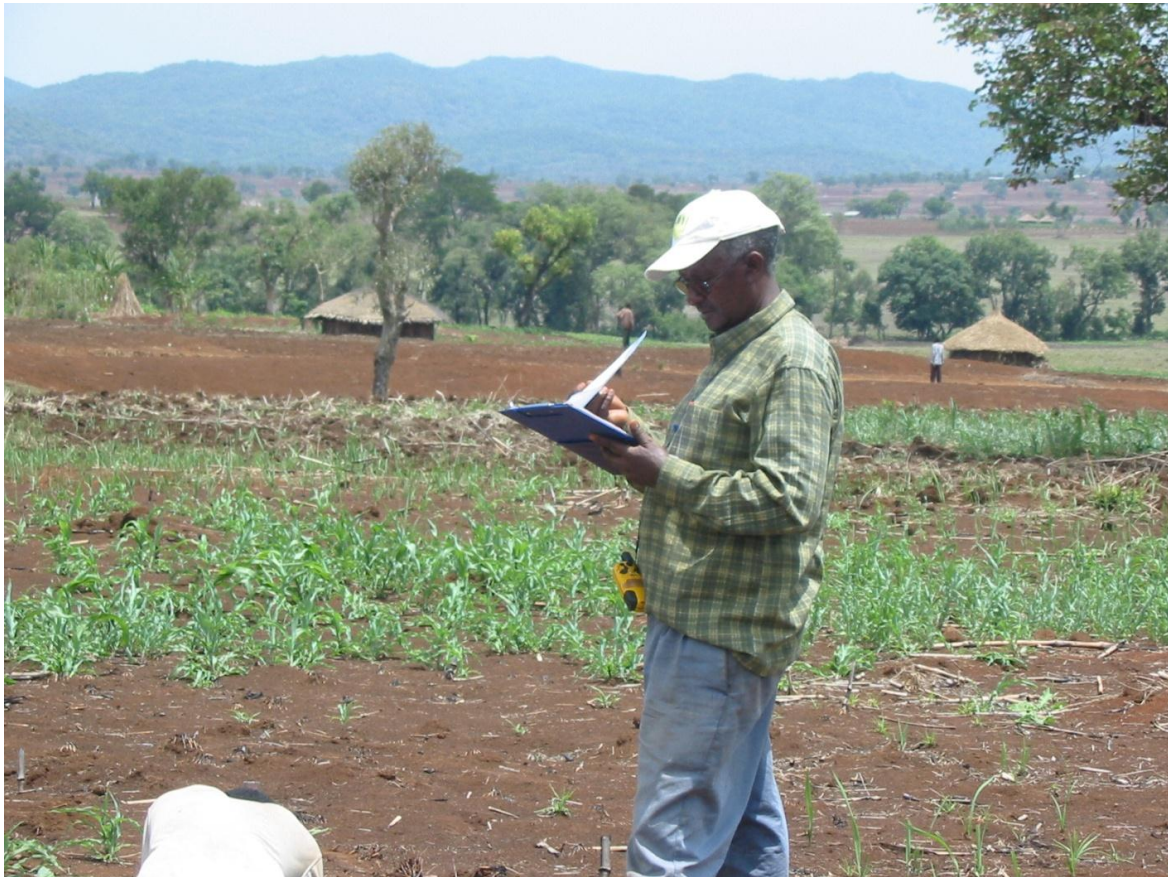
Plate 5.4: In-situ determination of hydraulic conductivity tests using inverse auger hole method

Hydraulic conductivity tests were also done in triplicate places using the inversed auger hole test method on 11 model profile pits, in places where soil infiltration tests were conducted. The data are illustrated in tables 5.4 and 5.5 respectively. Furthermore, picture taken during study time is also presented in Plate 5.4.

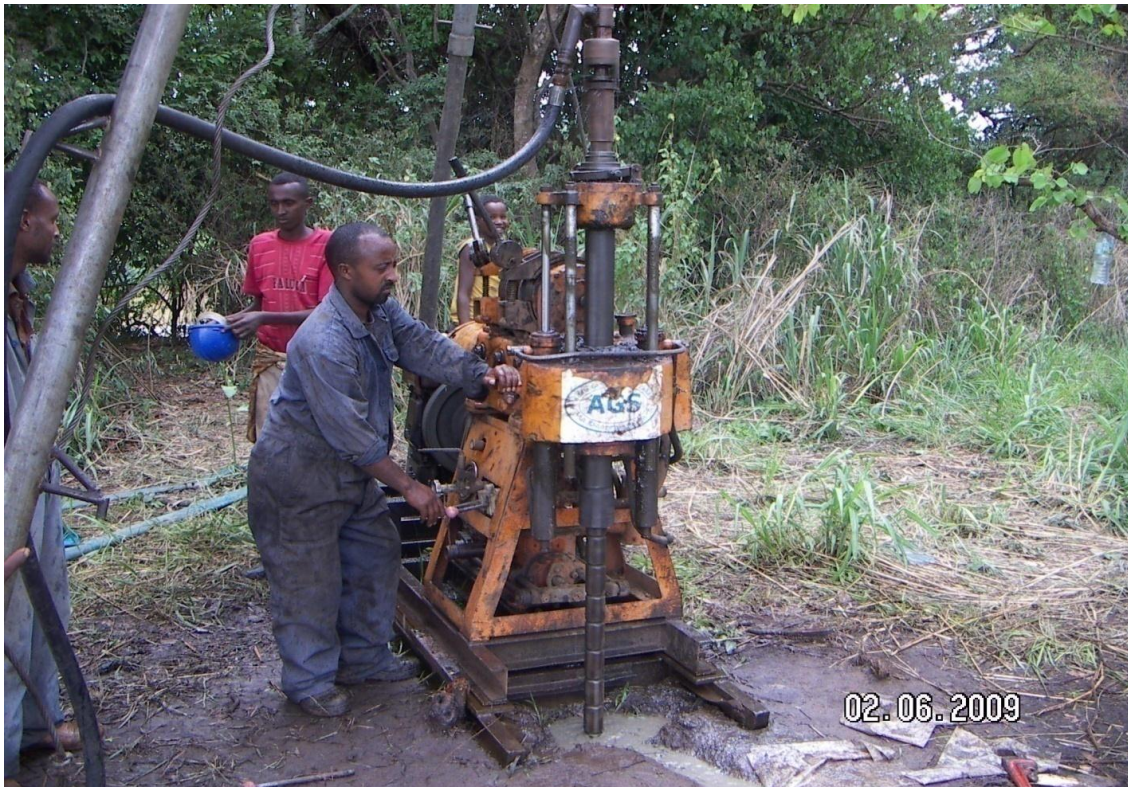
Plate 6.2: Drilling on progress at Borehole no DWBH - 1

Two boreholes with a total length of 22.90m were drilled to investigate the foundation condition of the weir site. The depths and general locations of the boreholes are given in the table below. Depth to bed rock, variation in rock quality, degree of weathering and fracturing of the rock mass and the like are the information collected from the cores of exploratory drillings and the boreholes.

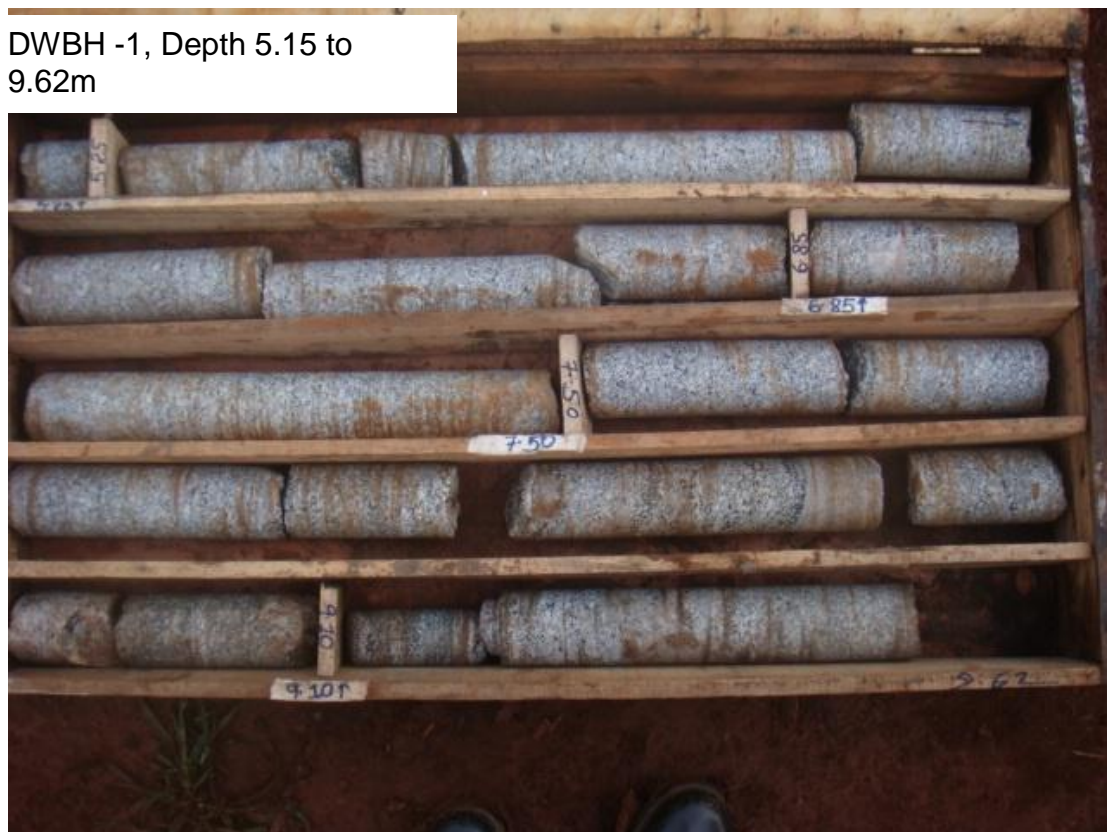
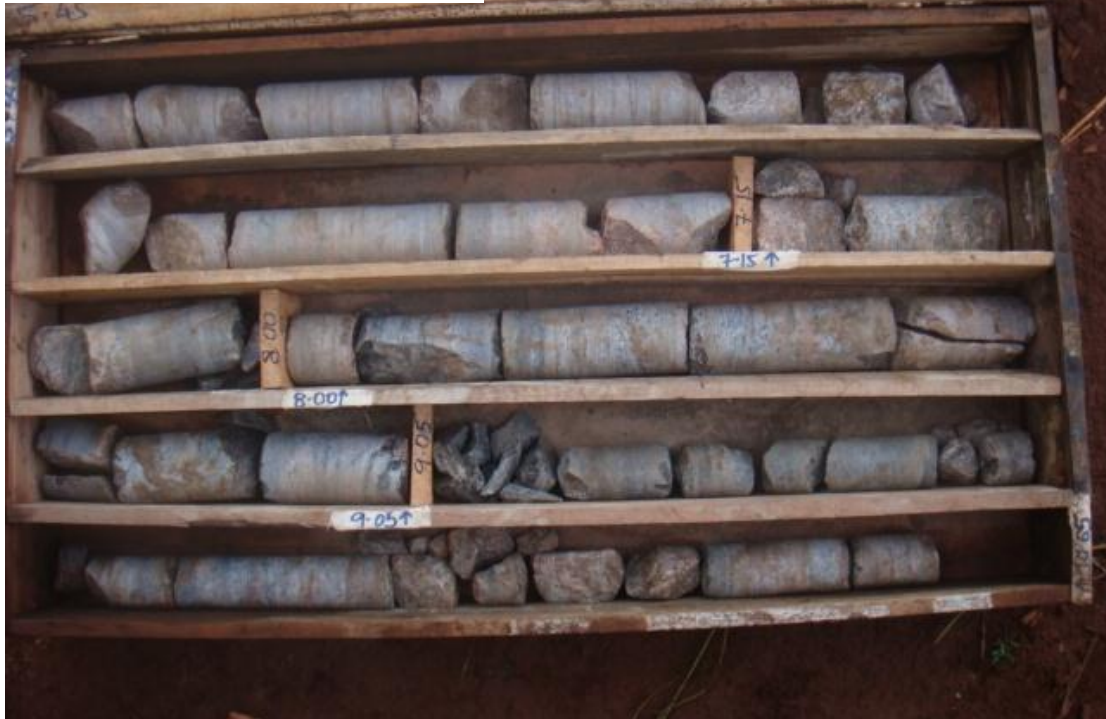
Plate 6.4: Variation of fracturing in both boreholes

DWBH -2, Depth 5.45 to
10.65m
