**Nile Basin Initiative
Nile Transboundary Environmental Action Project
Micro-Grants Program**

Soil Erosion Mitigation in the Nile Basin of Sudan

May 2005

Dr. Mekki Abdellatif Omer
National Consultant

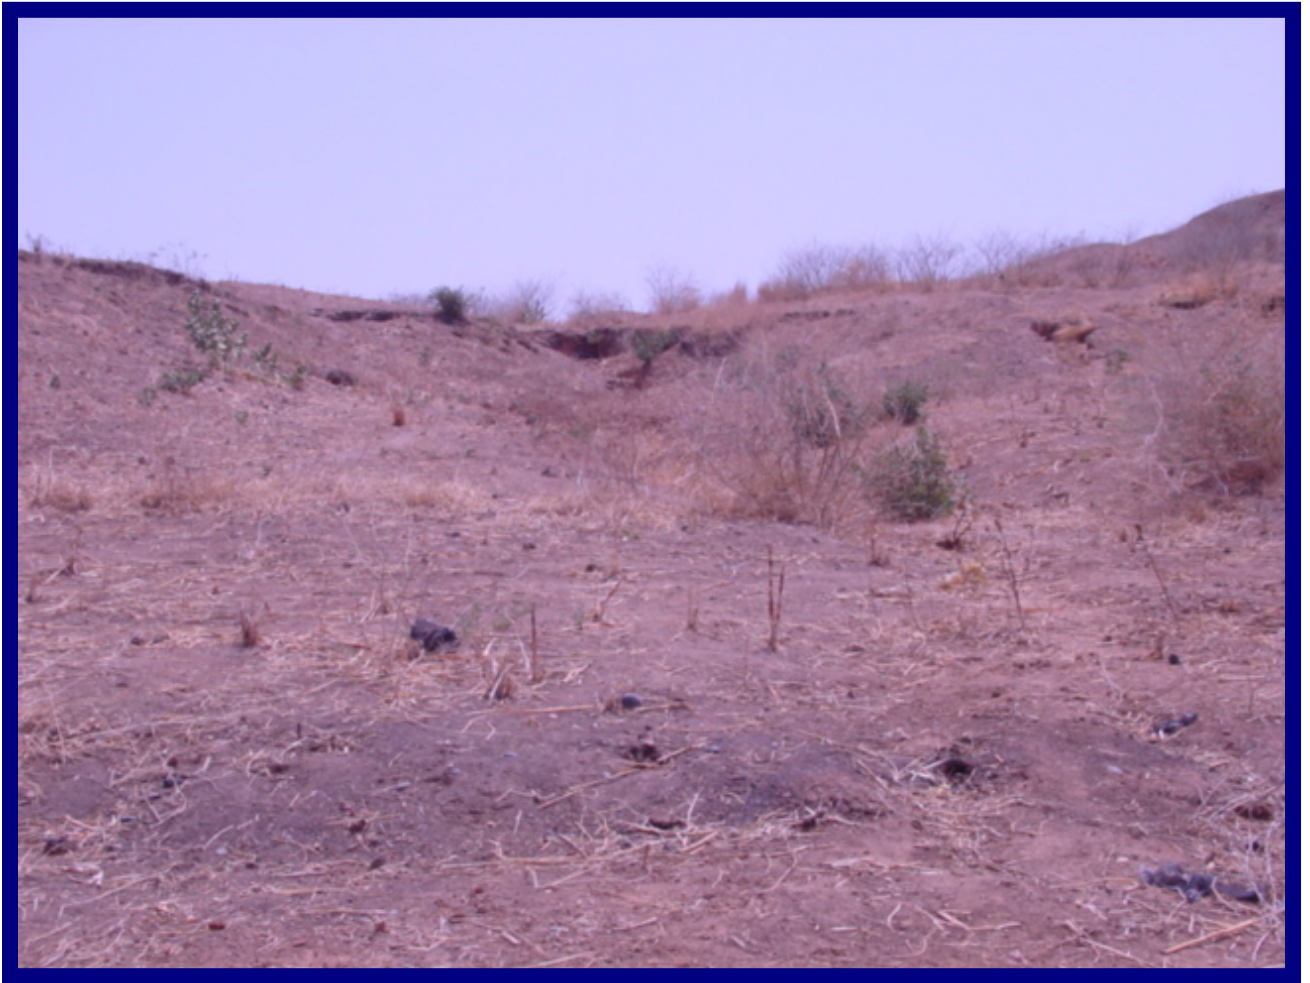
Most of the Kerib lands are normally devoid of tree cover or with sparse vegetation as a result of tree cutting for fuel wood and building purposes. In areas such as Al showak where some conservation practices by restocking of Kerib land using several tree species was undertaken by the Forestry Department, the distribution of tree is in such way that the tree cover in the gullies and side slopes is better and denser than in the top ridges and upper slopes. Indigenous grazable trees species like *Acacia tortilis* (seyal), *Acacia millfera* (Kitir), *Balanite aegyptiaca* (Hegleeg) and *Salvadora bersica* (Arak) are generally performing well. The planted Kerib land constitutes reserved forest for livestock grazing and browsing and well controlled by the local community on this area. This is a linking of conservation measures with community livelihood needs. The community believes that without this control, vegetation had no chance to recover when the dry season extends for 7 months and grass are lacking. In this area, grazing was intensive to extend that only few tree stands are existing before tree planting and management program were introduced. The bottoms of the gully floors are sometimes cultivated to millet, sorghum, okra and maize crop, making use of higher water content, which provides better conditions for both trees and crop growth such as at Umrabya in AlShowak and Abu Ramad in Damazin areas (**Plate No. 1**).

Plate No. 1: Cultivated gully floors in the Blue Nile area (UmRamad)

Gully erosion (Kerib) can be controlled in many ways. The most practical and simple means were rehabilitation of the Kerib land by construction of small check dams and planting of trees. Rehabilitation by planting trees was already initiated by the Forest National Corporation (FNC) with the participation of community in upper Atbara River, where the indigenous trees were found performing well. However, these initiatives need some improvement with respect to the type of enriching trees, density and associate conservation measure. The type of tree species such as *Acacia mellifer* and *tortilis* presently growing, although are indigenous, they are of low growth and density. Enriching of these trees by fast growing high density trees like *Acacia seyal* (Tilah), *Zizyphus spina Christi* (Cidir) and *Acacia nubica* (Laoat) can grow several times faster to reduce flow velocities and sediment load due to their soil binding properties and roughness effect.

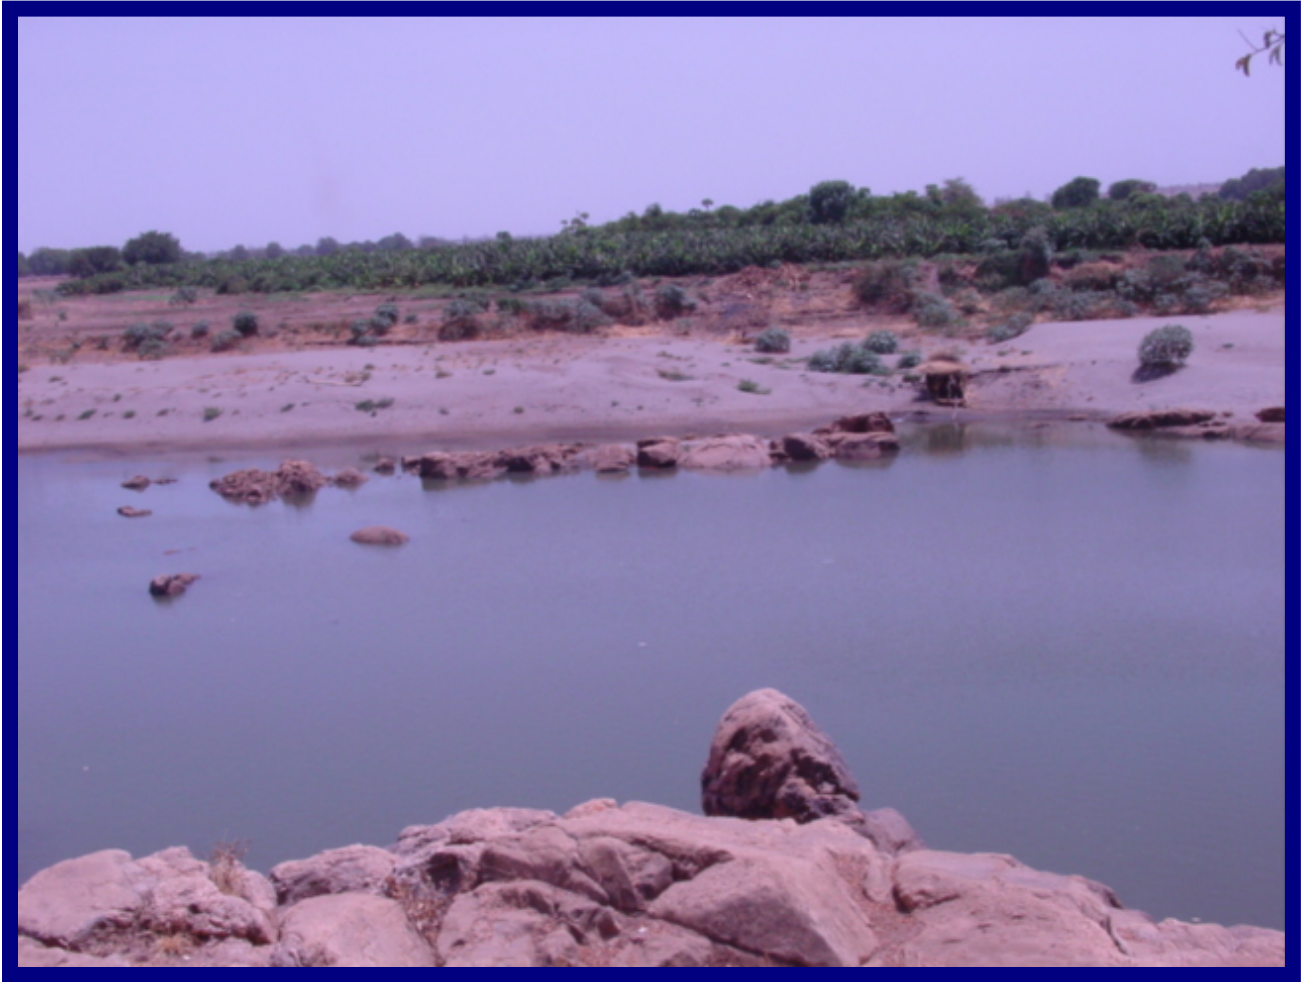
A big change in the river bank erosion magnitude in the southern Blue Nile area may be explained by the changing of the cropping pattern and management of the orchards along the Blue Nile. Initially these orchards are planted mainly to deep rooted trees such as mangoes and citruses and with good soil binding characteristics occupying 80 % of cultivated land and the remaining 20 % for banana trees. However, with the increase in the prices of banana, the growers tried in vain to increase their economic returns have removed or decreased the mangoes and citrus trees ratio to only 30 % and replaced them by banana (70 %) - **Plate No. 2**. The increased rate of bank erosion appears to have been influenced by this new cropping pattern.

Plate No. 2: Banana plantation on the Blue Nile banks (Roseiris area)

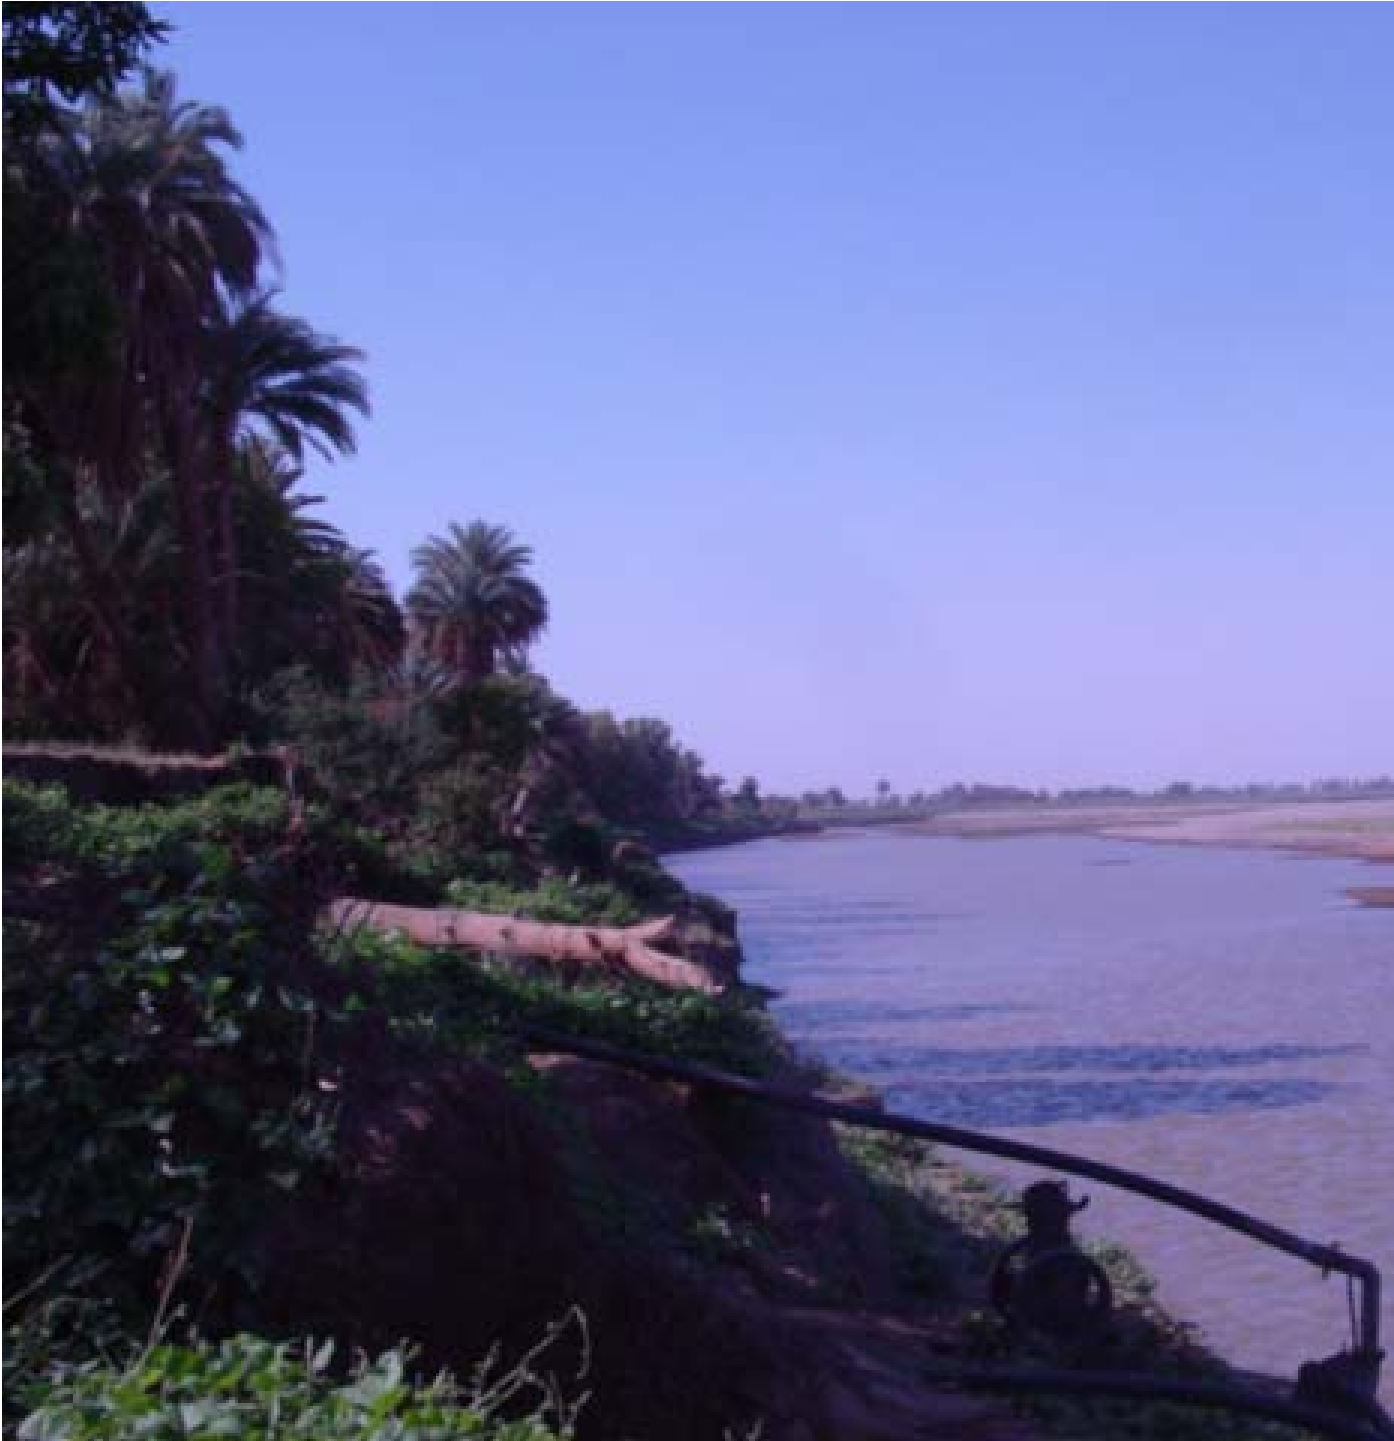
The large flow causes flood problem, bank overflow and surface drainage difficulties during the rainy season, and these flows are also responsible for bank erosion and sediment transport. The rapid drawdown of the Nile as a result of dam operation or seasonal drought is believed also to accelerate bank slides problem. Thus, these flows are believed to significantly influence the changes that may take place within the Nile course. In the process and attempt to restoring its equilibrium either aggradations or degradation, or both usually occurs. These are related to meandering pattern as an ultimate result of bank erosion along many reaches in the Nile. Nevertheless, the important areas experiencing serious bank erosion threats are the Northern regions of Sudan from Khartoum to the border of Egypt along the main Nile River. Condition of river bank erosion in the Northern region is not an exceptional. It is also depicted and documented along Atbara River and Blue Nile. At Atbara River the hot points are downstream of Khasm ElGrib dam. **(Plate No. 3)** The Blue Nile is exhibiting active bank erosion at different locations. The most serious suffering areas are downstream of Roseires dam, Singa to AlSuki, AlMseed, along Tuti's and Shambat area banks. Along the White Nile all banks seem to be stable or with little erosion. The river bank erosion was manifested into a number of damages and constraints that include:

Plate No. 3: River bank erosion along the Main Nile River (Barber area)

Generally options for controlling bank erosion are well known among professional engineers and recommendations were provided. However, most of these deal with engineering solution and used in limited scale, because of cost involved. The HRS (1990) recommended the following protection measures for bank erosion.

- Revetments to stabilize the banks following a stable slope.
This is used to protect the bank against the erosive power and wave's action of the flow.
- Groins to deflect strong current from the bank and enhance better conditions for deposition.
Groins are principally used to deflect strong current from the bank and provide conditions conducive to silt deposition, provided that groin characteristics such as length, angle and spacing are determined.

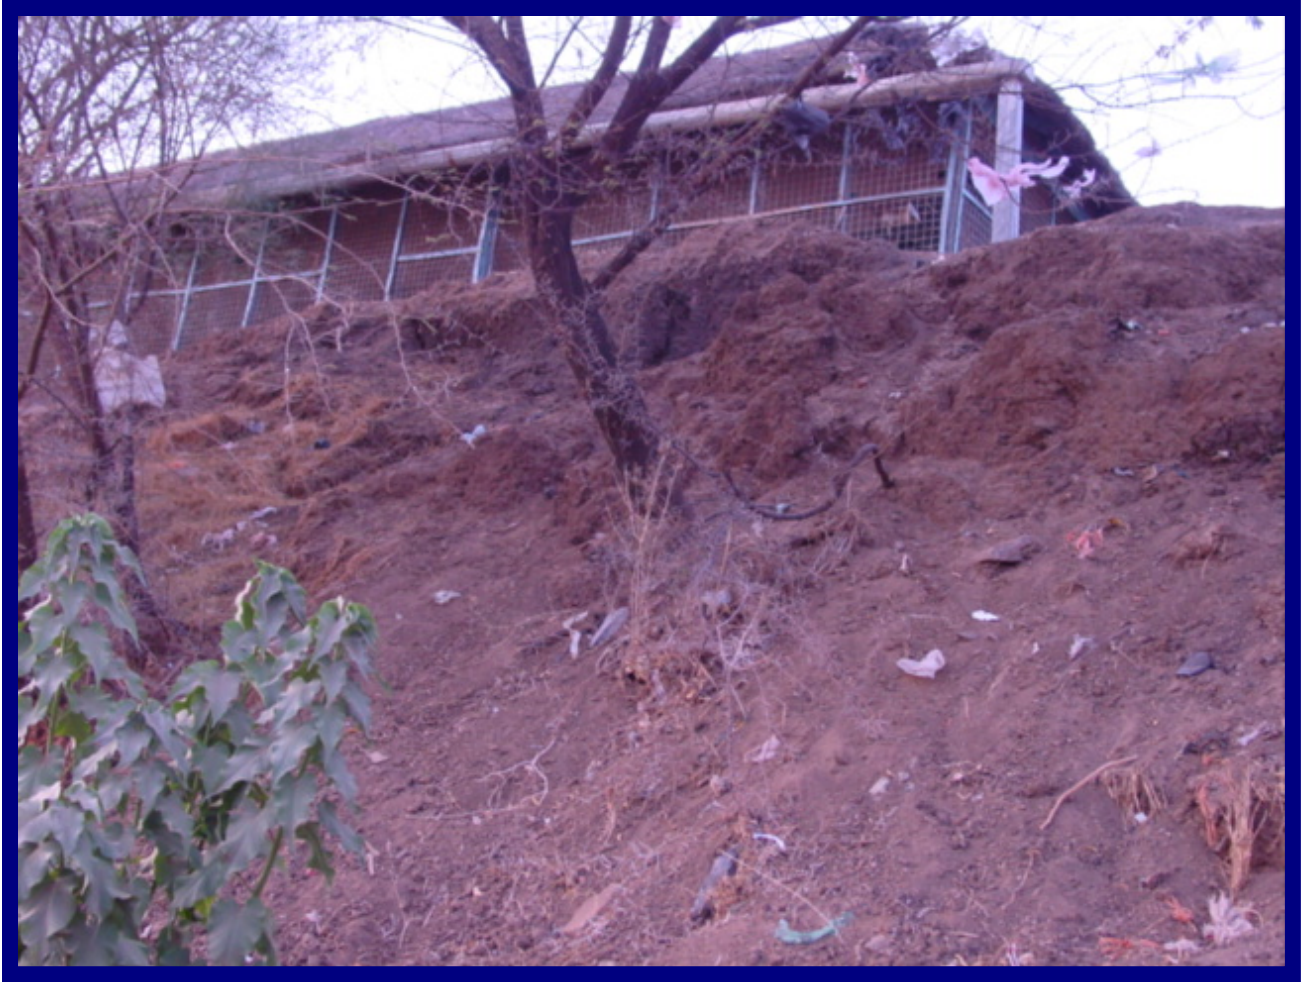
The real threats and adverse impact for the bank erosion was experienced on physical damage to buildings and other properties in the vicinity of its course. Typical example was the Forestry Department Rest House at AlSuki (**Plate No. 4**). The rest house which used to be about 120 m away from the shore is now nearly to collapse. Similarly pumping houses of many irrigation schemes and private buildings were reported collapsed under the influence of the bank erosion.

Plate No. 4: River bank erosion undermining property close to the bank (AISuki)

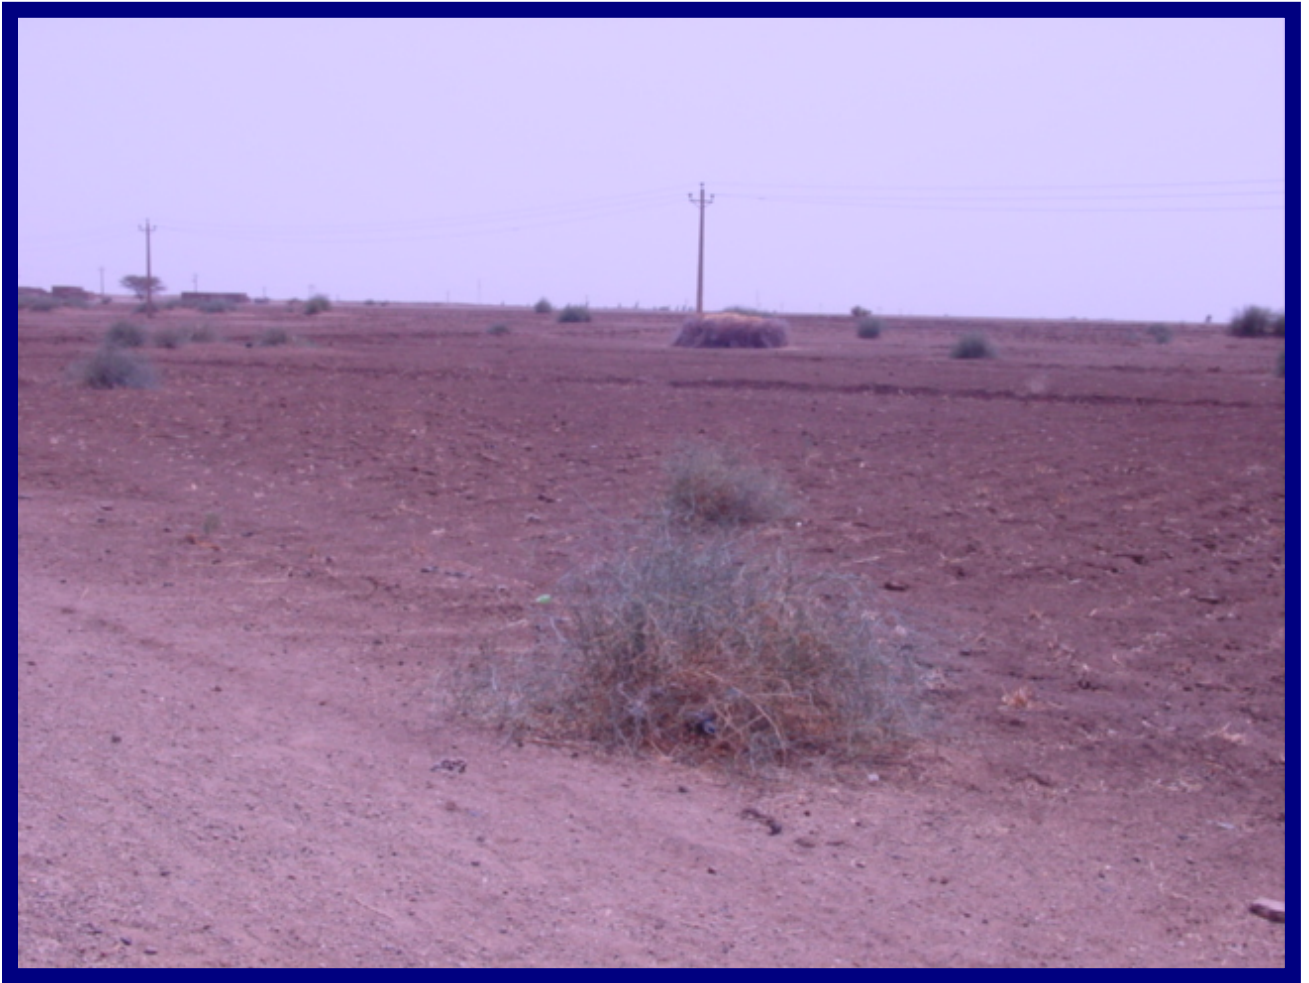
Plate No. 5: Lack of conservation practices on rain-fed agriculture

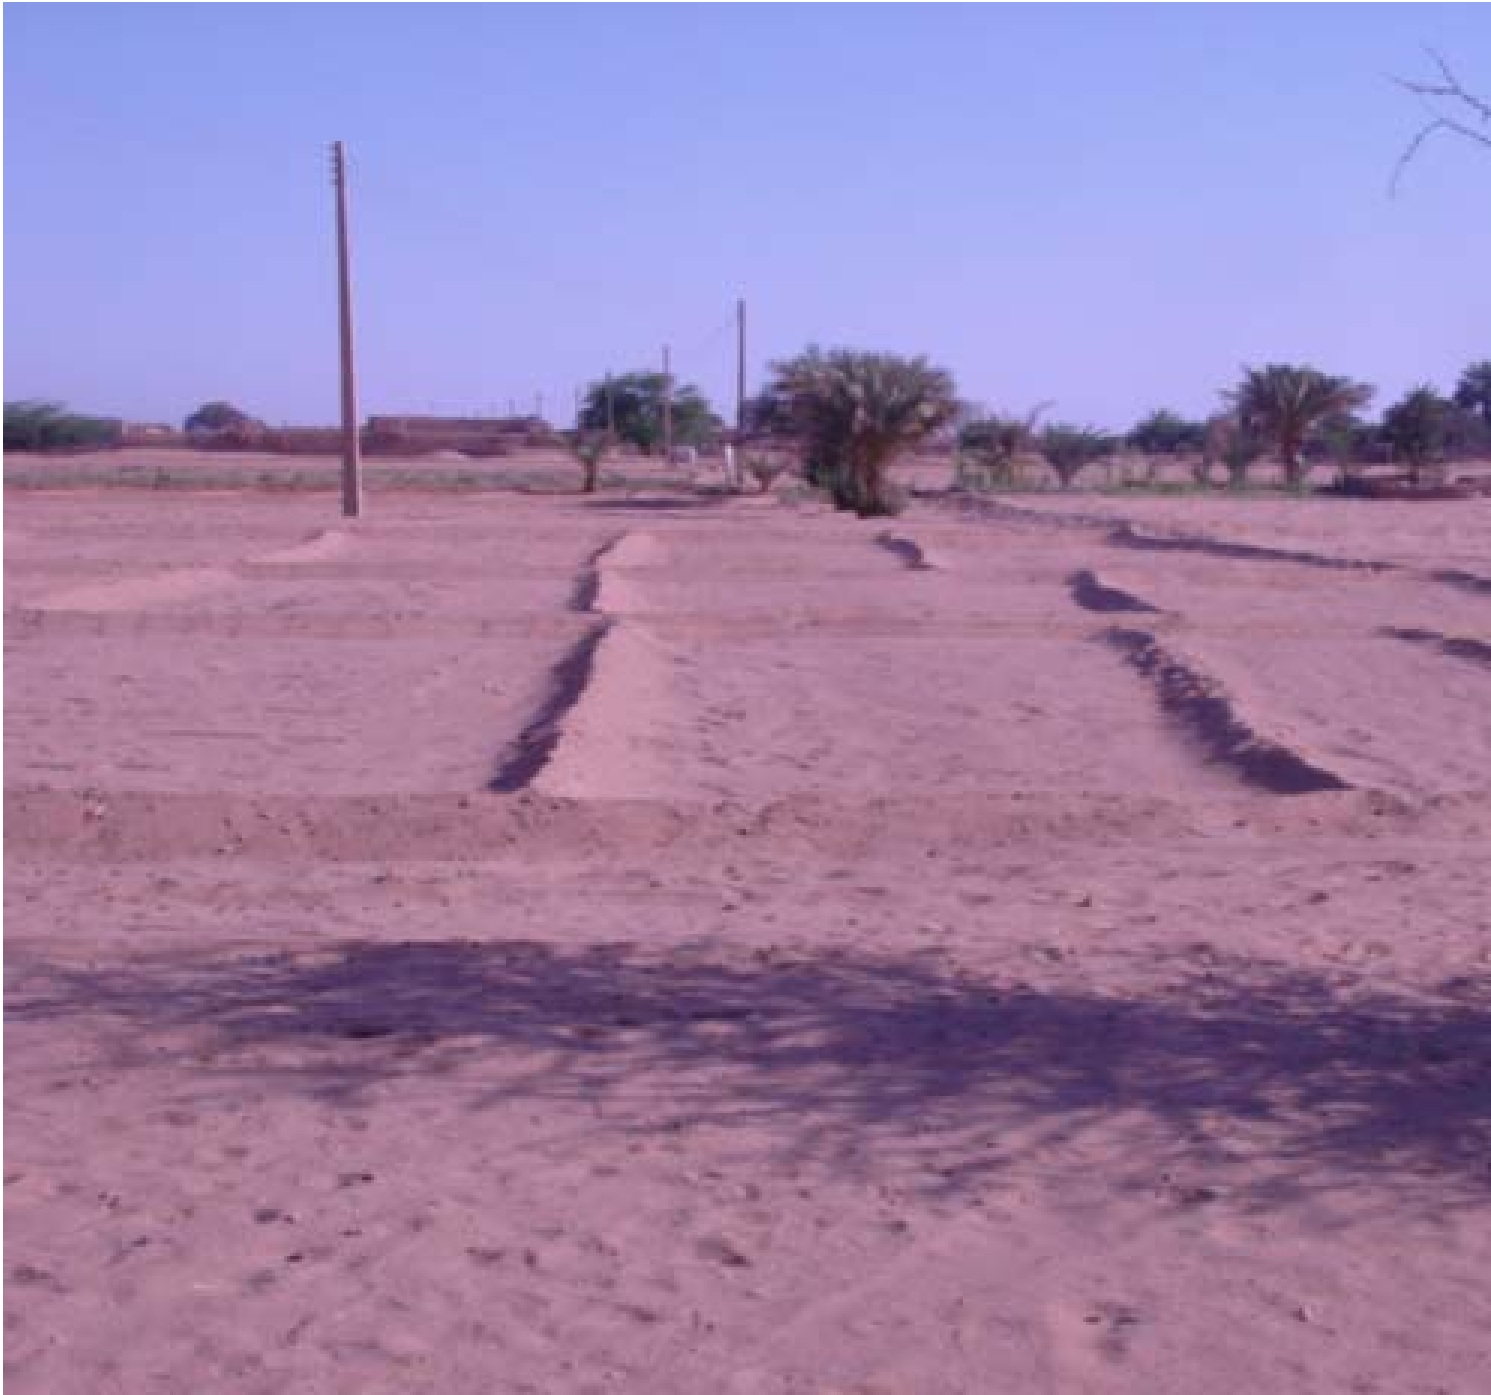
Result of field survey assessment about the wind erosion effect on some agricultural land on Lower Atbara indicates serious threat by the sand dunes movement over less than 10 years period(**Plate No. 6**). A large number of villages on those areas were found endangered, susceptible or even some dislocated such as Gozalhalag in 1988. The **table (9)** below presents a few examples of typical agricultural areas cover by sand. The table clearly indicates that in most sites about 30 % of cultivated area is invaded by sand dunes movement. At Lower Atbara and Main Nile the limited agricultural land stretched along the rivers course was significantly reduced and hampered by wind erosion deposition action.

Plate No. 6: Desert encroachment on arable lands (Alshigla village, north of Atbara town)

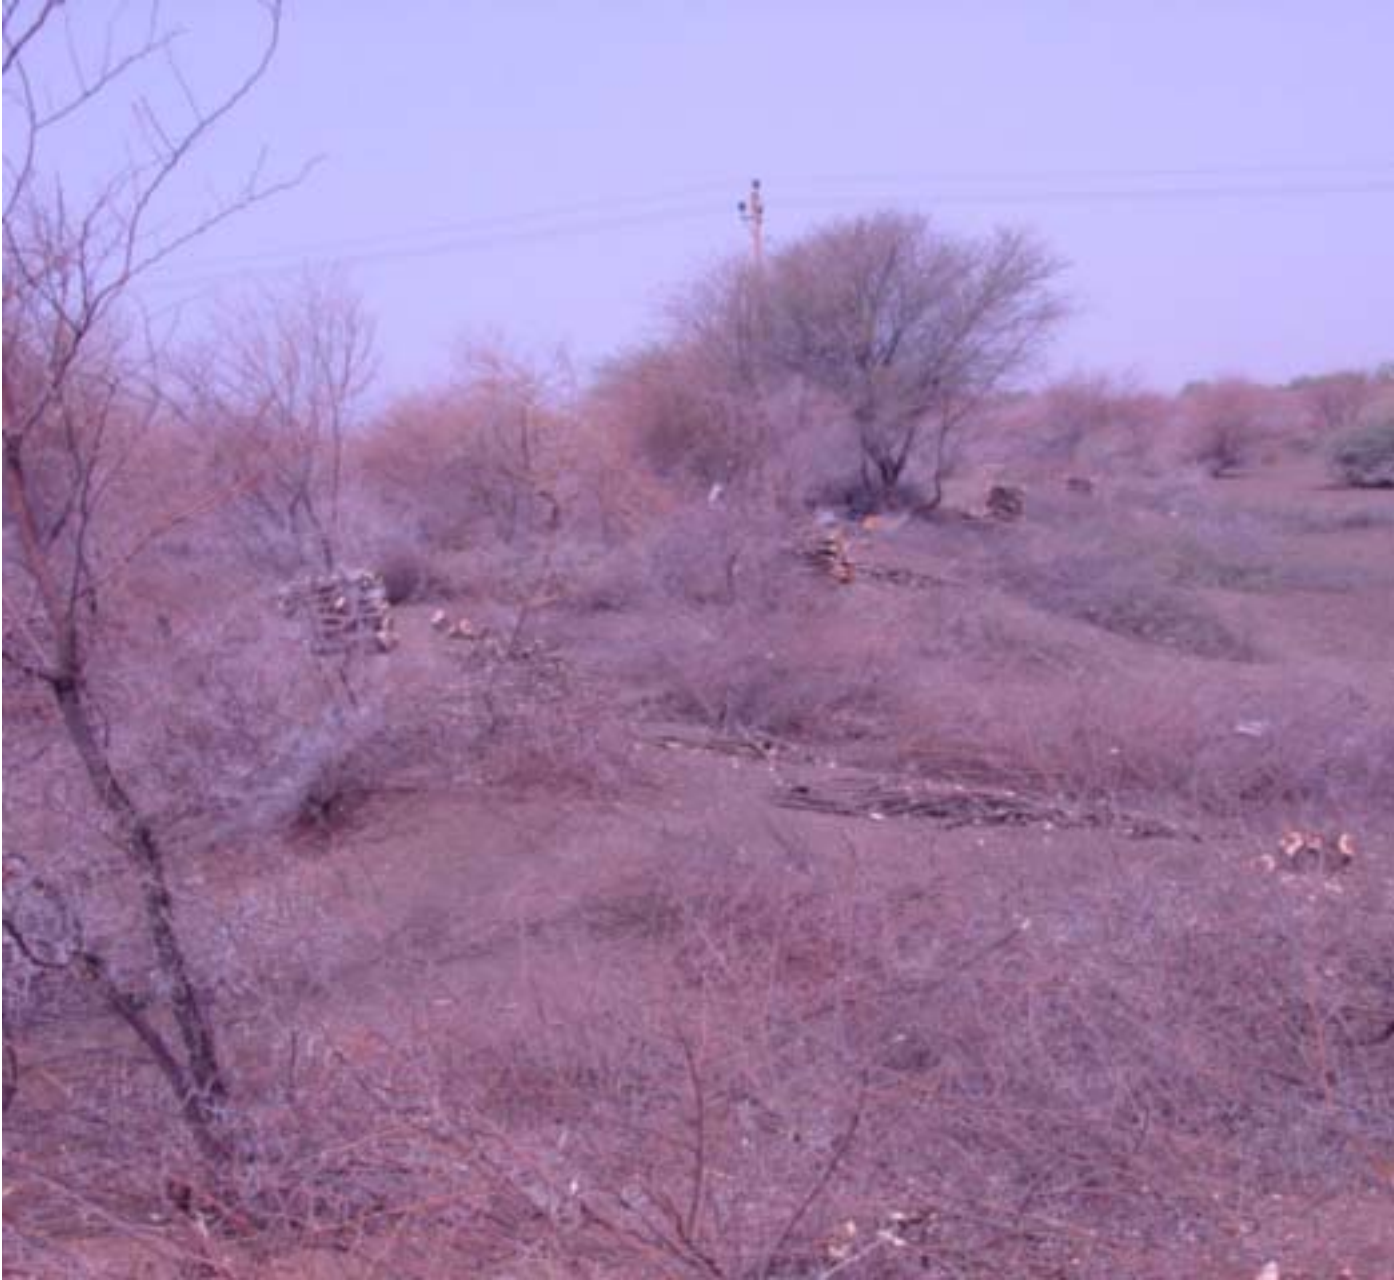
Forests management and their conservation are specifically important to maintain environmental stability and some economic benefits. This suggests that proper management of forest with involvement of community will not only provide them with fuel and fodder in sustainable manner but realized from various environmental advantages of erosion control. The work and experience of NFC showed that community-based organization participation in the management of their neighboring forests has been both environmentally and economical feasible. Planting of trees in cut and drainage areas in the irrigated agricultural schemes of ElRahad, Gezira, Suki, New Halfa and Blue and White Niles pump schemes has been promising technique to provide valuable trees products to the community, beside its complimentary effects of controlling both water and wind erosion (**Plate No. 8**).

Plate No. 8: Cut and drainage area planted to trees lot
