THE IMPACT OF THE 2020-2021 RISING WATER LEVELS IN UGANDA'S MAJOR LAKES AND LESSON LEARNT, A CASE STUDY OF LAKE KYOGA AND ALBERT.

BY AJOK PASKA

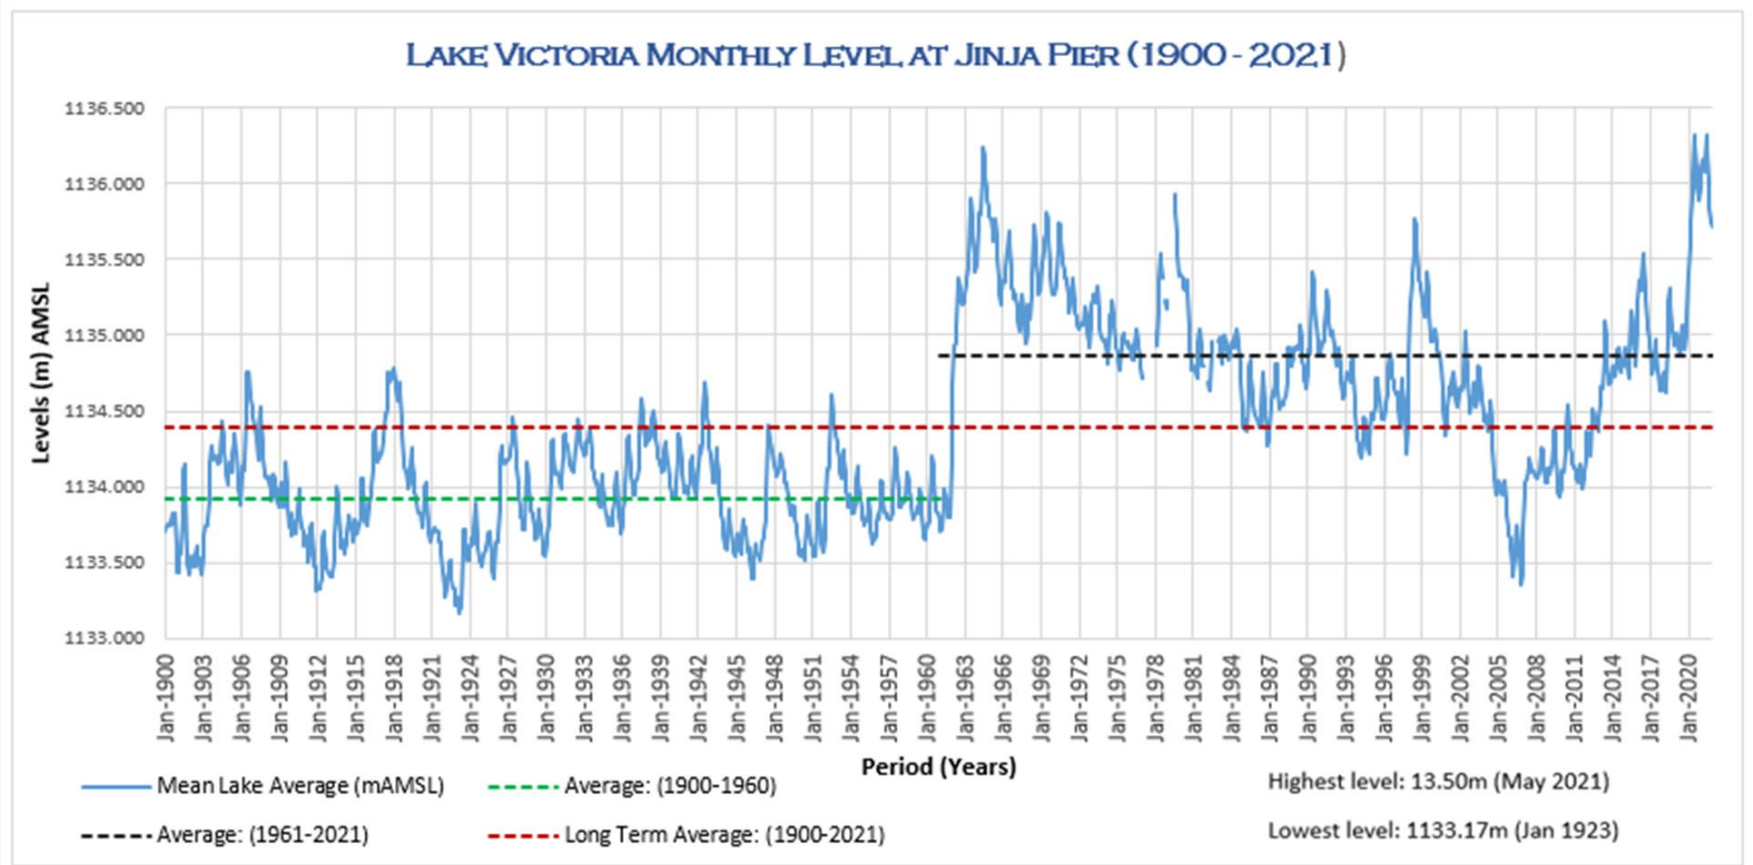
Lake Victoria levels

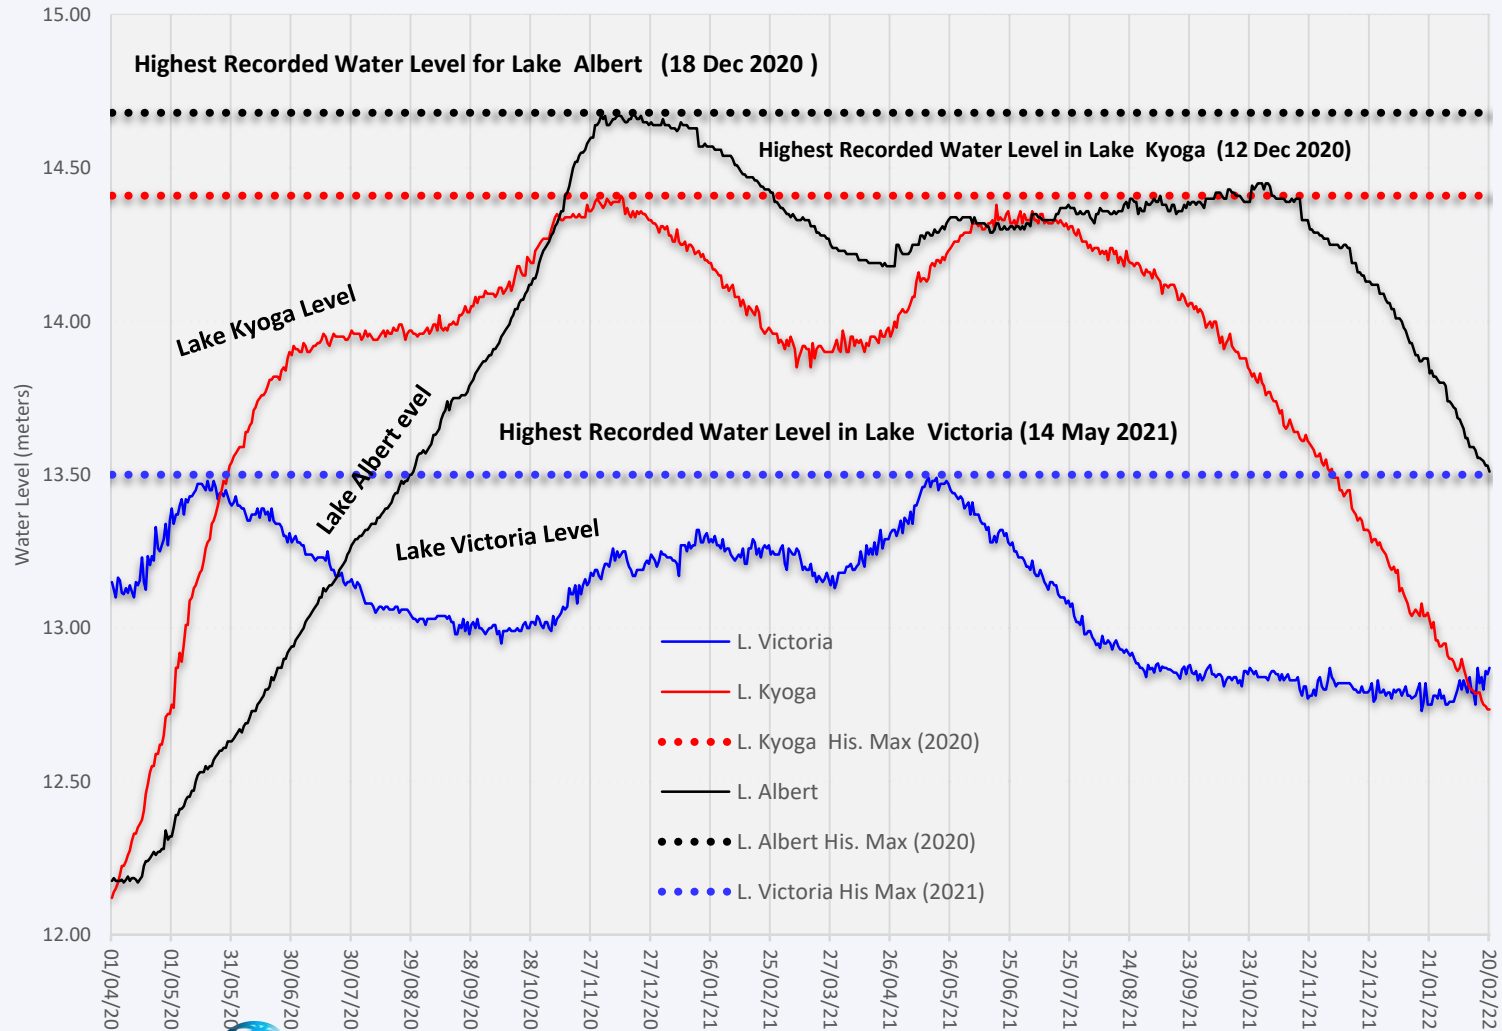
Lake Kyoga, Albert and Victoria levels from 2020-2022

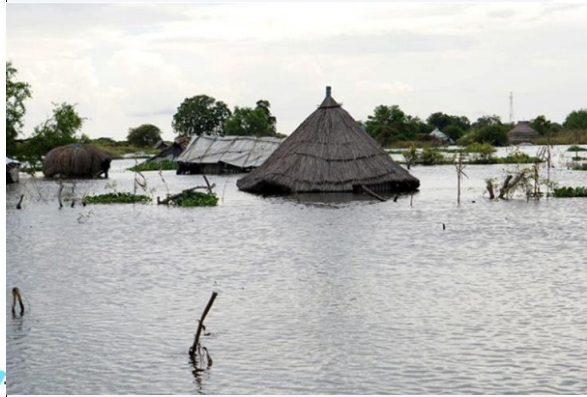
2020-2021 flood extend lake Kyoga
