STUDY ON THE INTERCONNECTION OF THE ELECTRICITY NETWORKS OF THE NILE EQUATORIAL LAKES COUNTRIES

FEASIBILITY REPORT VOLUME 2 C – UGANDA-KENYA INTERCONNECTION LINE ROUTE AND GEOTECHNICAL INVESTIGATIONS

NOVEMBER 2007
N°1 36 0300

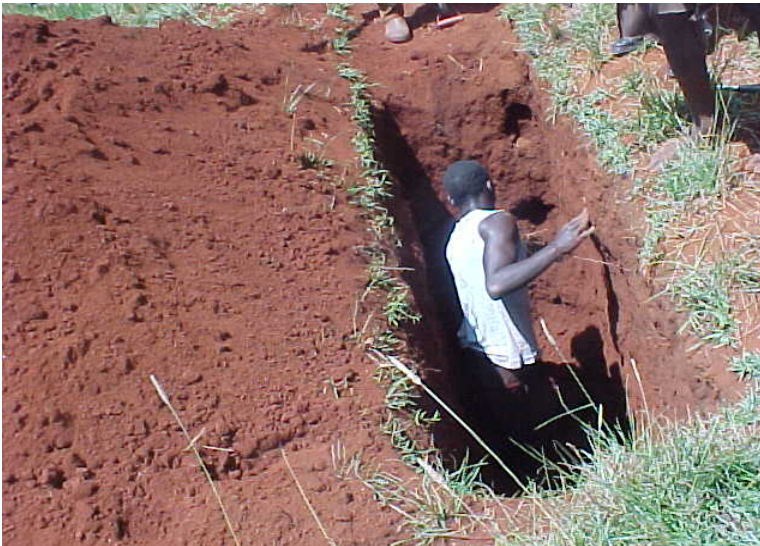
Plate 1 Soil profile

The soil profile was dug at 10 m interval to the depth of at least 4 m, depending on the presence of the bedrock or extremely compact layer. Different soil layers were identified and studied on the basis of soil characteristics such as colour, texture, depth, consistence, erodibility and drainage.

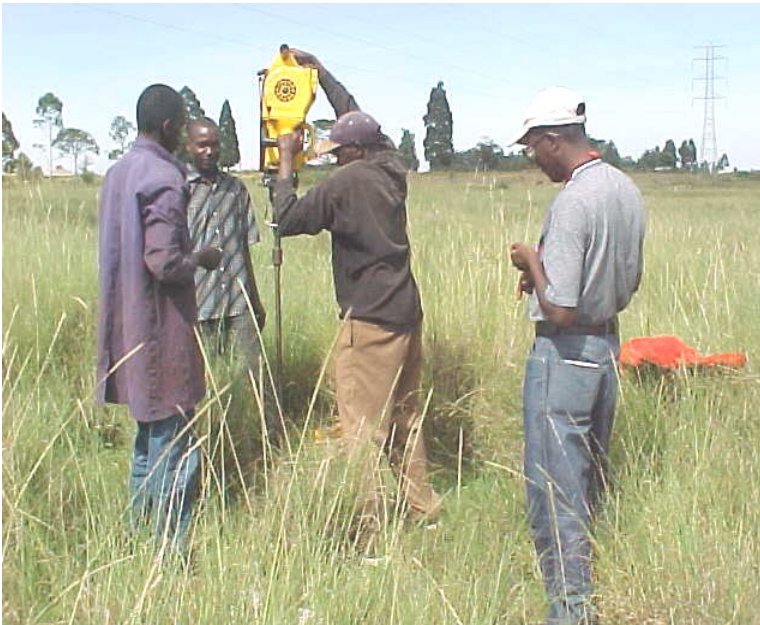
Plate 2 Dynamic sounding test at different depth

- (3) The engineering properties included maximum safe bearing capacity of the soil, depth to hard formation, liquid limit and natural soil moisture content. The maximum safe bearing capacity of the soil was determined using the results of shear box tests, based on the analysis of Mohr Stress Circle and Coulomb Equation. The depth to hard layer was determined using dynamic sounding (Plate 2).

This involved determination of the time taken by the rod of specified dimension to penetrate 1 meter soil depth at different soil layers, when subjected to force of specified magnitude. The test continued until a layer was incurred through which the rod could not penetrate. That particular depth was noted for different soil profiles, each profile representing the probable location of the pylon.

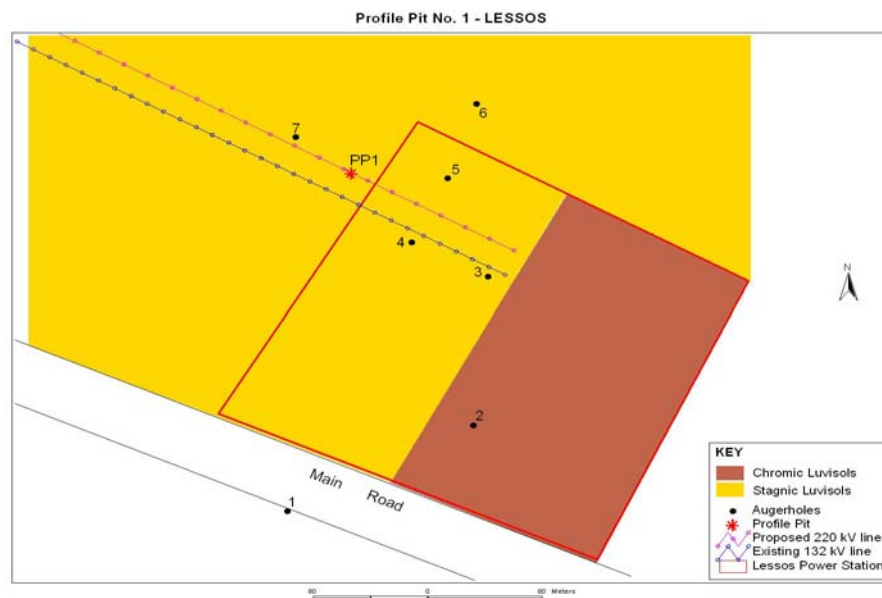
Figure 9: A GIS map showing the location of the soil profile pit, the location of the auger borings and the generally covered area on observation No 1.

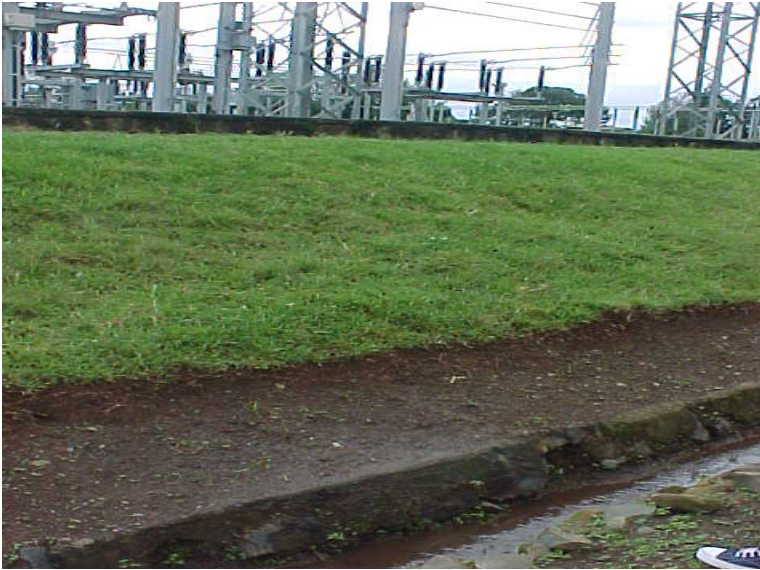
Plate 3: Stable environment

Upper part of the site

Materials of soil excavated from the surrounding areas and compacted to form a terrace with steep sides and flat top on which the engineering structures are constructed. The grass cover is over 95%, making the soil stable against the water flow through seepage and erosion (Plate 3).

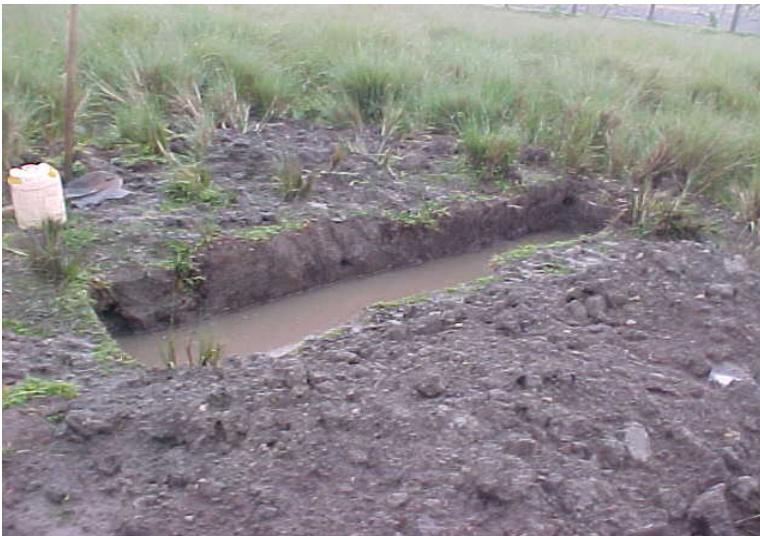
Plate 4: Poorly drained conditions

Poorly drained bottomlands

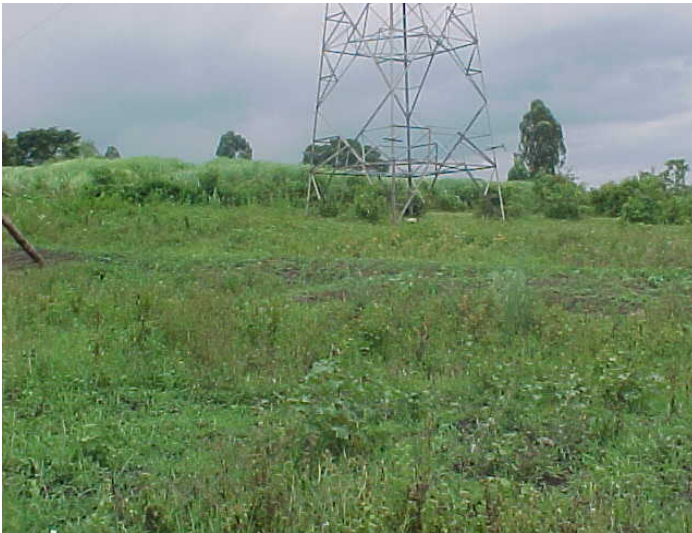
Plate 5: Good land cover and stable conditions

Erosion risk and bearing capacity: There is little erosion risk (Plate 5) because the topography is nearly flat with good cover.

A combination of good ground cover and relatively gently slopes and little disturbance through human influence make the majority of the sampling points stable against landslides, slumping and mass movement that may interfere with the functions of the pylon. However, there are isolated cases where poor ground cover and land degradation processes are a problem

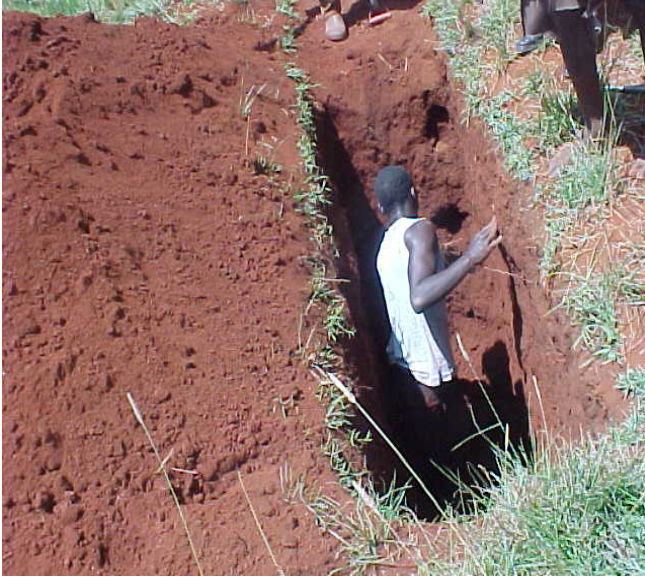
Plate 6: A typical Nitisol

The red soils in the between Lessos and Tororo and mainly Nitisols. The soils occurs predominantly on the uplands and footridges. Most of them are extremely deep and well drained with well formed, stable structure, with clear planes of cleavage. They have very high water uptake and retention characteristics, hence no inundation and poor drainage conditions are experienced during the rainy season. This, together with non-shrinking and expanding clay, as well as good grass cover make the soil very stable against external forces such as erosivity and human influence.

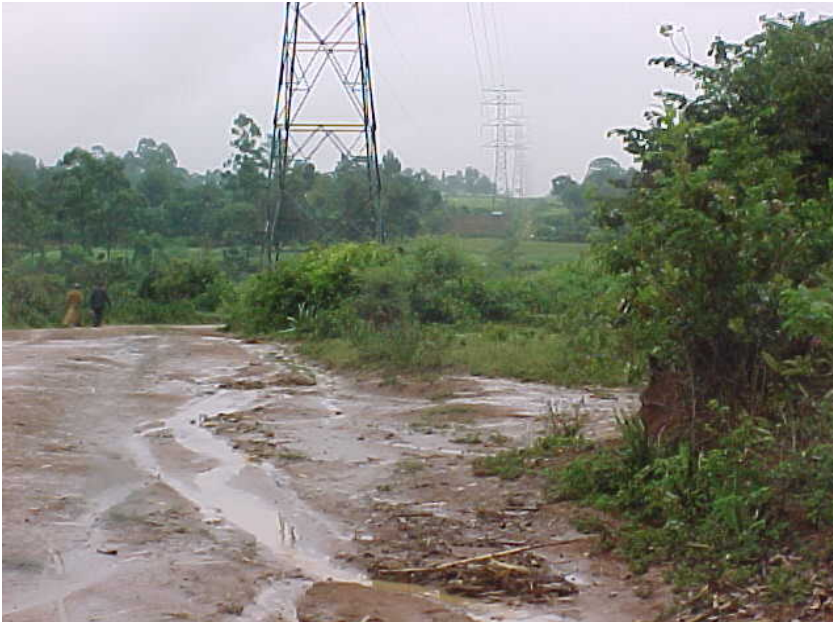
Plate: 8 High erosion risk along the road

The water flow taking place along the road is directly flowing into the pylon. Therefore, the proposed location for the new pylon should be on the area above this point on stable soil with cemented murrum at the depth ranging from 10 to 30 cm. The negative effects of erosion is noted in 6, where there is a threat to expose the foundation footing of the old pylon.

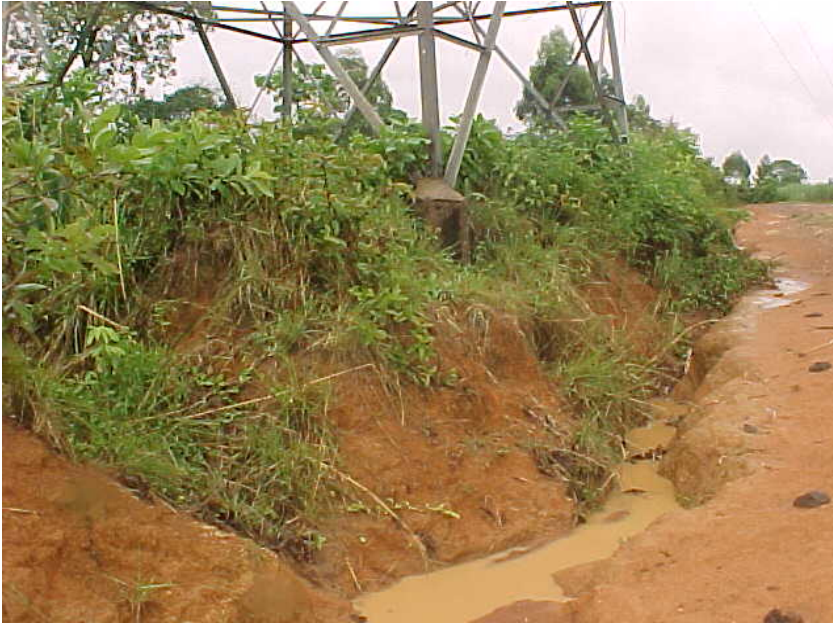
Plate: 9 Threat against the pylon foundation

The concentrated flow enhanced by the road has continually dug the soil towards the foundation footing to a depth more than 1 meter. It is remaining less than a meter to reach the foundation footing of the old pylon. This will disrupt the stability of the structure, hence its function. Therefore, this factor has to be taken into account when designing and constructing the new pylon.

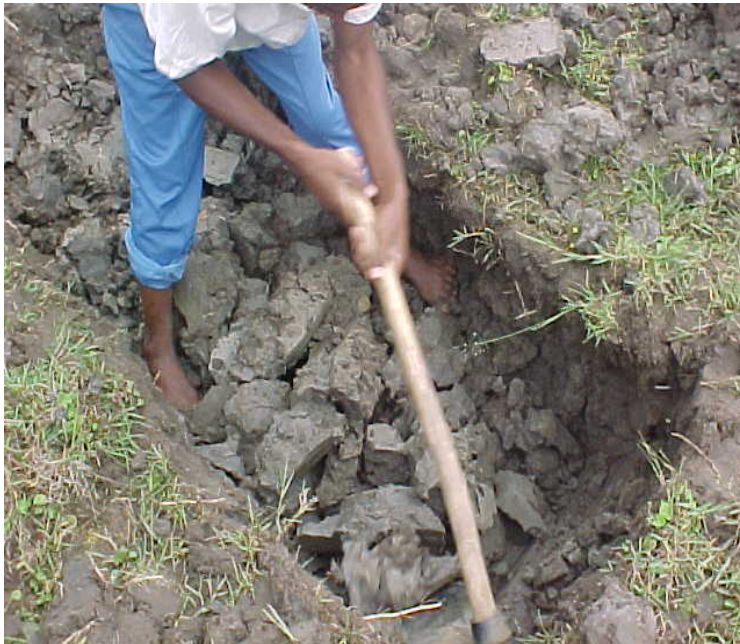
Plate: 10 Firm and highly compact profile

The heavy, firm and compact clay in the sub-soil accounts for extremely low water uptake into the soil surface. This causes the impeded drainage thereby resulting into poor drainage conditions and inundation during the rainy season. However this may not cause a serious problem to an engineering structure because the sub-soil being firm and compact allows little water into the soil profile. The water only stands on the surface and is subjected to evaporation

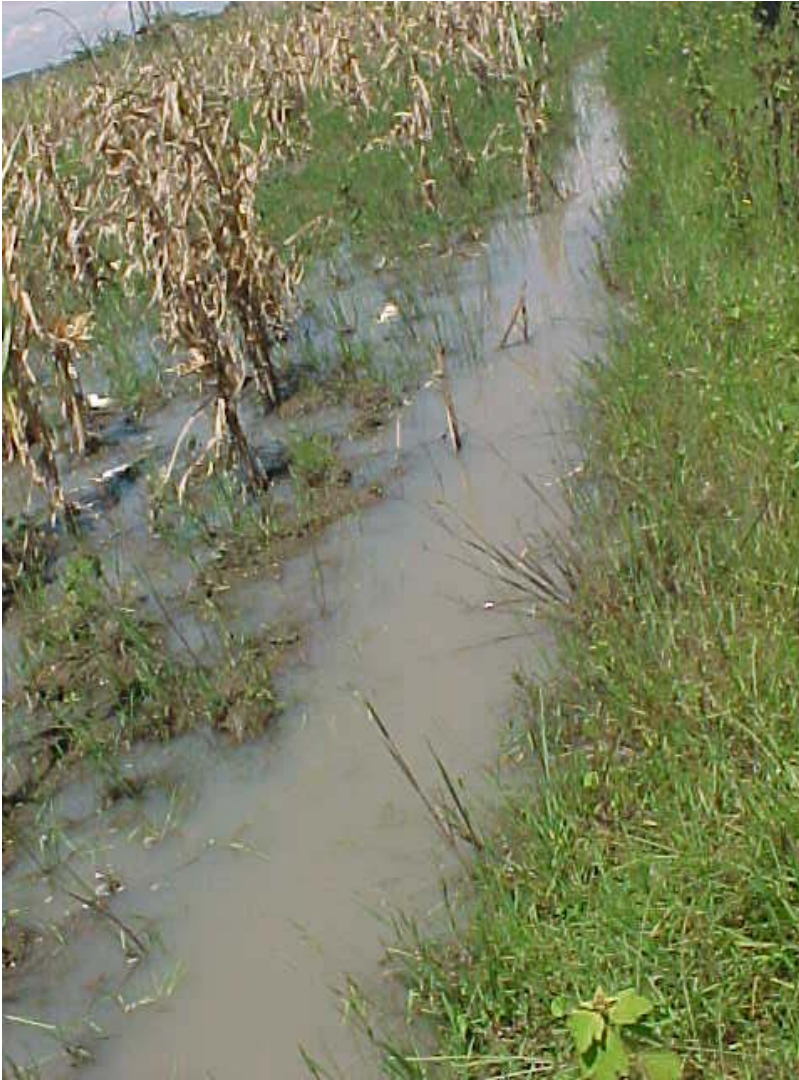
Plate 11: Poor drainage conditions

Low water permeability because of the impeded drainage causes the water to stand on the surface after the rains.

The observed management strategies on the ground by most farmers are raised cumber bed, which not only results into improved porosity, but also reduced compactness, thereby improving the water uptake and retention capacity

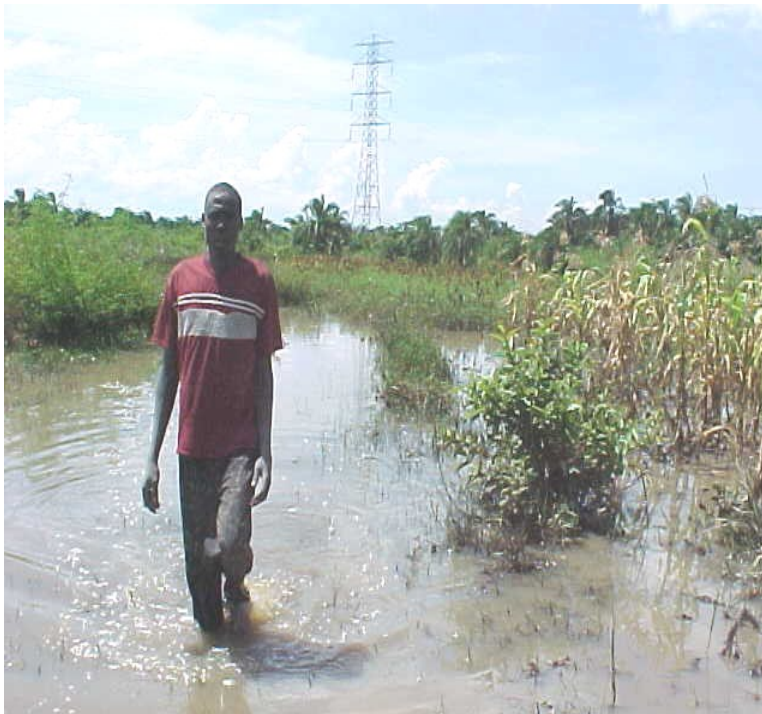
Plate 13: Waterlogged conditions

Erosion risk and bearing capacity: The drainage condition is extremely poor with water standing on the surface condition of water logging is common in this unit. The area is Swampy meaning that the pylon would be erected in water-logged ground near a river(Plate 13), which borders Kenya and Uganda. The pylon is at risk and already KPL has put stones to repair the pylon. There is no accessibility to the pylon due to water. These soils are Luvisols and vertisols.

Poor drainage conditions and waterlogging may require the construction of the raised grounds the same way it is in Lessos in a similar conditions to improve the environmental stability for the pylon construction.

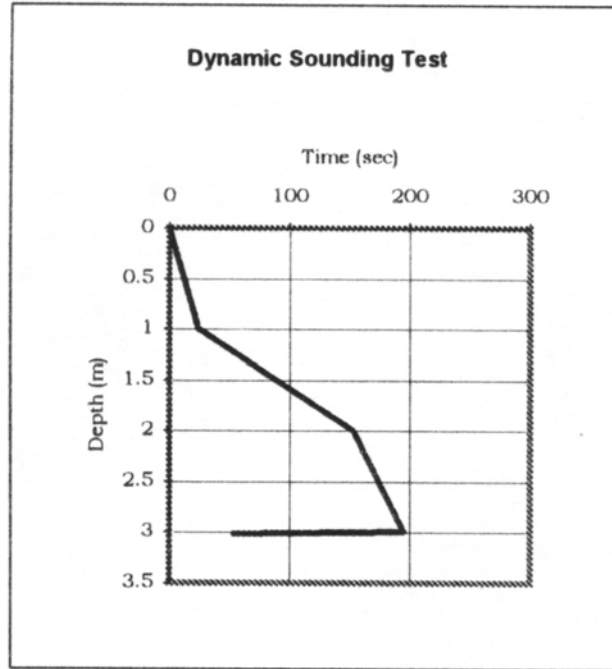
Point 1

Dynamic test for representative sampling points.

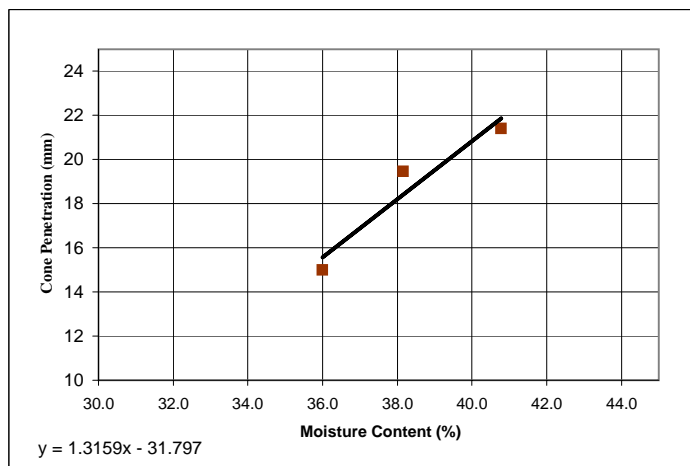
LIQUID LIMIT		1	2	3	4	5
Initial dial gauge reading	mm	0	0	0	0	
Final dial gauge reading	mm	15	15	19.5	19.4	21.3
Cone Penetration	mm	15	15	19.5	19.4	21.3
Average cone penetration	mm	15	19.45	21.4		
Container no.		M	702	W		
Mass of wet soil + container	g	36.7	43.90	45.30		
Mass of dry soil + container	g	29.5	34.40	34.90		
Mass of container	g	9.5	9.50	9.40		
Mass of moisture	g	7.20	9.50	10.40		
Mass of dry soil	g	20.00	24.90	25.50		
Moisture content	%	36.0	38.2	40.8

LIQUID LIMIT	38.8	%
PLASTIC LIMIT	24.0	%
PLASTICITY INDEX	14.8	%

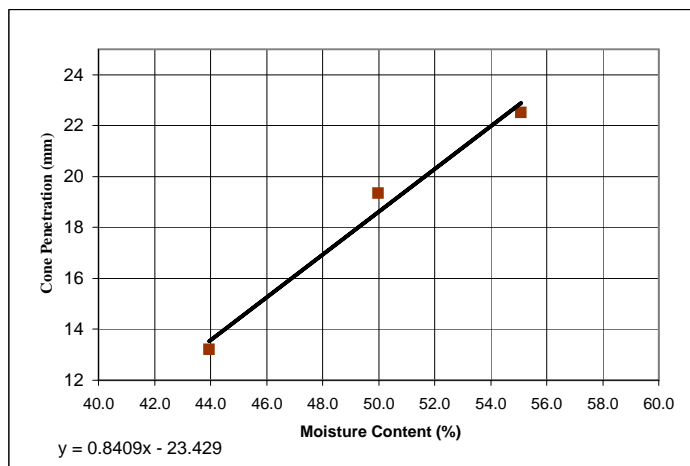
LIQUID LIMIT		1		2		3		4		5	
Initial dial gauge reading	mm	0	0	0	0	0	0				
Final dial gauge reading	mm	13.2	13.2	19.2	19.5	22.5	22.5				
Cone Penetration	mm	13.2	13.2	19.2	19.5	22.5	22.5				
Average cone penetration	mm	13.2		19.35		22.5					
Container no.		117		702		65					
Mass of wet soil + container	g	40.9		26.90		40.70					
Mass of dry soil + container	g	32.9		21.10		31.50					
Mass of container	g	14.7		9.50		14.80					
Mass of moisture	g	8.00		5.80		9.20					
Mass of dry soil	g	18.20		11.60		16.70					
Moisture content	%	44.0		50.0		55.1

LIQUID LIMIT	51.8	%
PLASTIC LIMIT	25.5	%
PLASTICITY INDEX	26.3	%

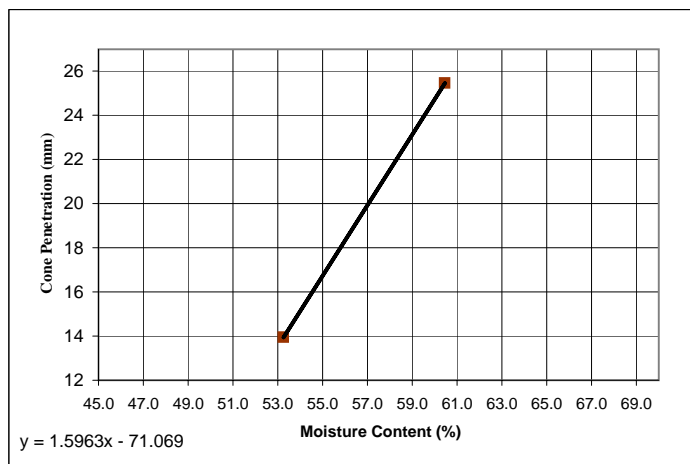
LIQUID LIMIT		1		2		3	4	5	
Initial dial gauge reading	mm	0	0	0	0				
Final dial gauge reading	mm	13.9	14	25.4	25.5				
Cone Penetration	mm	13.9	14	25.4	25.5				
Average cone penetration	mm	13.95		25.45					
Container no.		10		OO					
Mass of wet soil + container	g	42.9		43.10					
Mass of dry soil + container	g	33.1		32.70					
Mass of container	g	14.7		15.50					
Mass of moisture	g	9.80		10.40					
Mass of dry soil	g	18.40		17.20					
Moisture content	%	53.3		60.5

LIQUID LIMIT	57.0	%
PLASTIC LIMIT	29.1	%
PLASTICITY INDEX	27.9	%

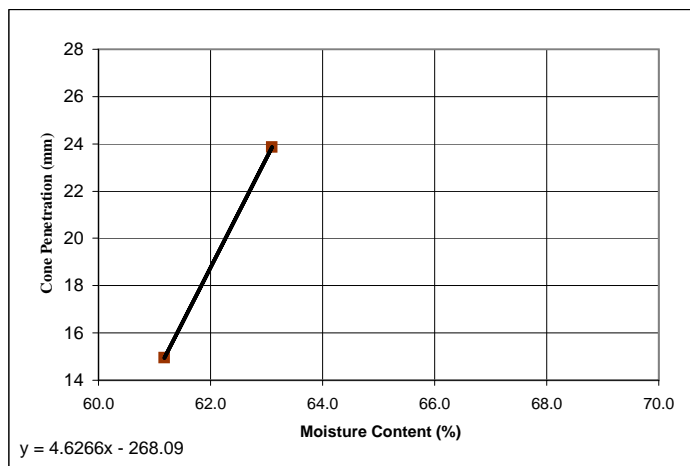
LIQUID LIMIT		1		2		3	4	5
Initial dial gauge reading	mm	0	0	0	0			
Final dial gauge reading	mm	15.0	14.9	23.8	23.9			
Cone Penetration	mm	15.0	14.9	23.8	23.9			
Average cone penetration	mm	14.95		23.85				
Container no.		642		6300				
Mass of wet soil + container	g	37		29.60				
Mass of dry soil + container	g	26.6		21.79				
Mass of container	g	9.6		9.40				
Mass of moisture	g	10.40		7.81				
Mass of dry soil	g	17.00		12.39				
Moisture content	%	61.2		63.1

LIQUID LIMIT	62.3	%
PLASTIC LIMIT	29.9	%
PLASTICITY INDEX	32.4	%
